Trailer not secured in place before it was disconnected resulting in damage to fence

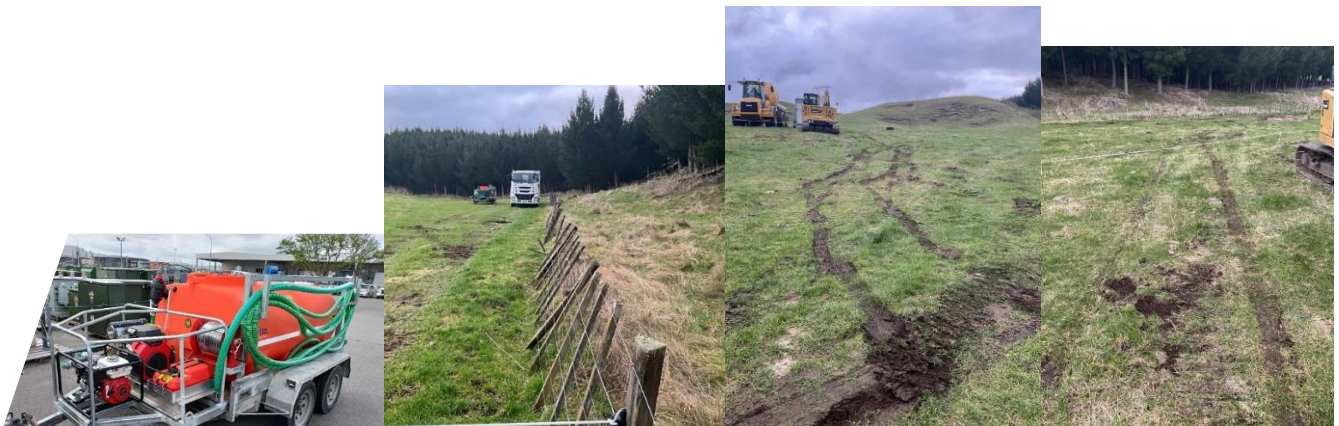
Photos from Left (1) similar water cart trailer, (2) damage to fence (3&4) Incline and Path of travel

On 25 June 2025 at approximately 4:30 pm, a worker was returning a full 1800L water cart trailer to its point of use at site. The orientation of the trailer and tow vehicle was in line with the slope and facing uphill. Before fully securing the trailer, the worker removed the light plug and disconnected the safety chain, followed by unlatching the coupling and jockey wheel. At this stage the trailer coupling was resting on the tow ball but not secured. After partially lowering the jockey wheel, the worker noticed the wheel chocks were not in place and went to retrieve them from the flat deck ute. While unattended, the coupling unexpectedly disengaged from the towbar. As a result, the trailer rolled away uncontrolled (approximately 50m) and collided with a nearby fence, causing damage. There was no risk to people or animals.

- Incident was immediately reported to Transpower and Landowner.
- Site made safe; the damaged fence was temporarily repaired, and a full repair was completed the following day.
- Incident reported to Maximo (179007) and ICAM Investigation is now underway.
- Reminder issued to team regarding proper trailer securing procedures, including the use of wheel chocks prior to decoupling. This will also be raised at the next toolbox session.
