# QUALITY ALERT!

Maximo ref 176626  
8th July 2025

## Silica gel breather transport seal causes transformer trip

Quality Alert ref. 2025-007

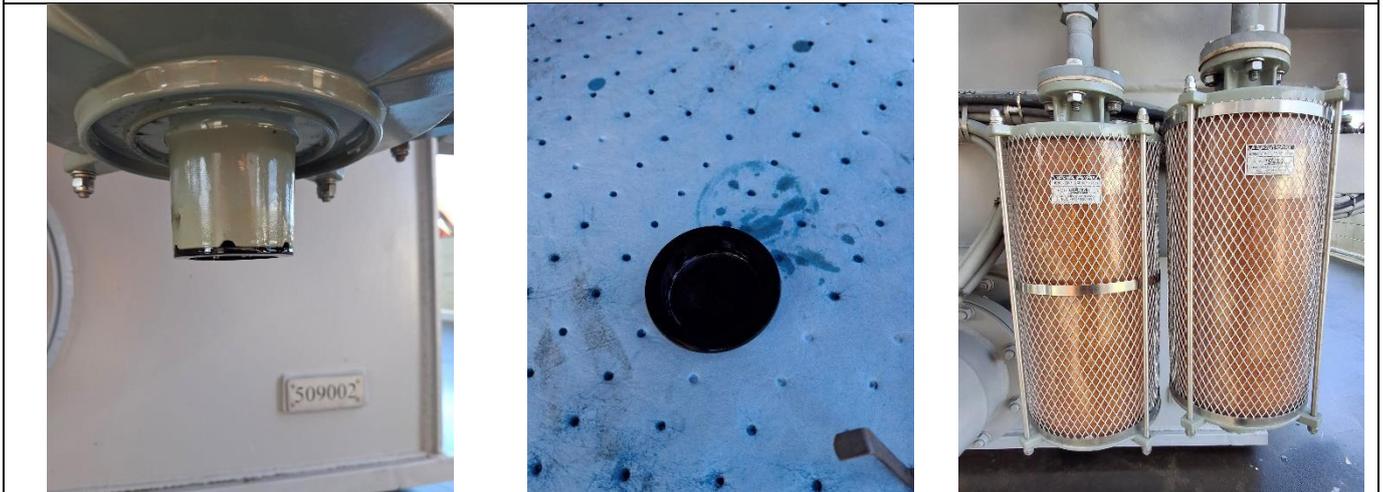
- NGOC notified the service provider about a transformer trip and a pressure relief value (PRV) alarm.
- The silica gel breather had a transport protection cap left on the bottom of the air inlet which meant the transformer was sealed and could not breathe leading to the PRV to operate and tripping of the transformer

- During routine maintenance work (9 months before the incident), the replacement and installation of silica gel breather units took place.
- An investigation found the silica gel breather had a protection cap left on the bottom of the air inlet, this resulted in blocking the air breather unit and built internal pressure which released from the PRV.
- Maintenance worker did not identify the transport seal on the silica gel breather.
  - There are two transport seal caps to remove, the top seal is red, and the bottom seal is black.
  - The bottom black seal was missed, and the worker did not identify the seal as it was not the same as the top seal.

- Inspect the silica gel unit to ensure no obstructions prevent the air flow to the breather.
- Provide additional training for maintenance workers reminding them of the importance of removing **all** transport seals and how to identify them

All silica gel units undergoing maintenance with the replacement and installation of silica gel breather units should be inspected to ensure no obstructions prevent the air flow to the breather and **both** transport caps have been removed
