# ENVIRONMENTAL ALERT

Date: 20/05/2025  
Maximo no. 178080

## Oil Pod Falls from Forklift

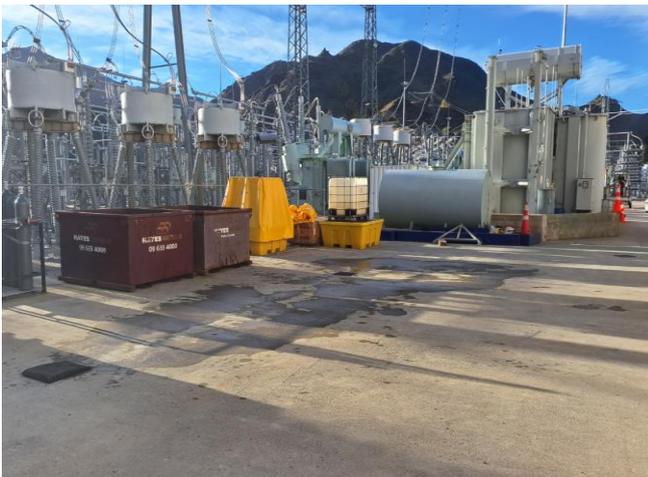
Workers moved an oil pod and its bund using a forklift. The load fell from the forks, causing a spill of around 250 litres of transformer oil. Most of the oil was contained within the surrounding concrete surface, and a small amount entered the drain leading to the oil containment tank. There was no contamination to the environment.

The oil spill occurred on the concrete oil catchment area.

- The Forklift Operator did not secure the load to the forklift.
- The load was 'top heavy' due to water sitting in the rain cover along with 250 litres of oil in the pod. This created an unstable load when moved.

- The oil containment tank valves were closed.
- An immediate spill response was actioned using nearby spill kits.
- The Transpower Project Manager was notified.
- The tank was later pumped out by a third party.
- Simply Green solution was used to clean the residual layer of spilled oil on the concrete surface.

- Unstable loads need to be secured to the forklift prior to any movement.
- Forklift Operators are to conduct risk assessment of loads, especially liquid loads, which can change the centre of gravity when being moved.
- If the load is not static and is 'top heavy' there is the potential for the load to fall off the forks and must be secured.
