## Risk of Electric shock from Temporary Power Supply

As part of final work activities at the Wilton Substation, it was observed that a power extension lead was routed under the door and extended beyond the controlled area, through the fence line, beyond the earthgrid, where the work area was set-up. The following hazards were identified:

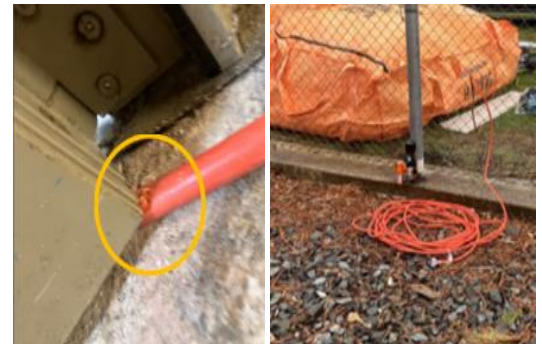
1. The extension lead crossed beyond the Earthgrid (*potential step-touch risk during fault event*).
2. The extension lead was not protected, causing an abrasion to the cable's outer sheathing (*potential risk of electric shock from the door, had the damage to the lead continued*).
3. The new lead was not tested and tagged (*a non-compliance to the SSSP and industry best practice*).
4. No RCD protection

- The damaged lead was unplugged and discontinued use.
- Replaced power tools with battery-powered tools.
- A toolbox talk was conducted prior to work restarting with all staff involved to reinforce the critical importance of using only tagged and tested equipment, ensuring appropriate cable routing of leads, and always maintaining safe setup procedures.
- Incident raised and investigation underway.
