Date of Event: 28/05/2025

An experienced distribution line mechanic (LMD1) received a 230V shock to the leg from the exposed end of a live LV cable, that had just been cut to length, during a de-energised pillar replacement task. The lineperson was uninjured other than experiencing the shock.

Safety Alert-2505-01

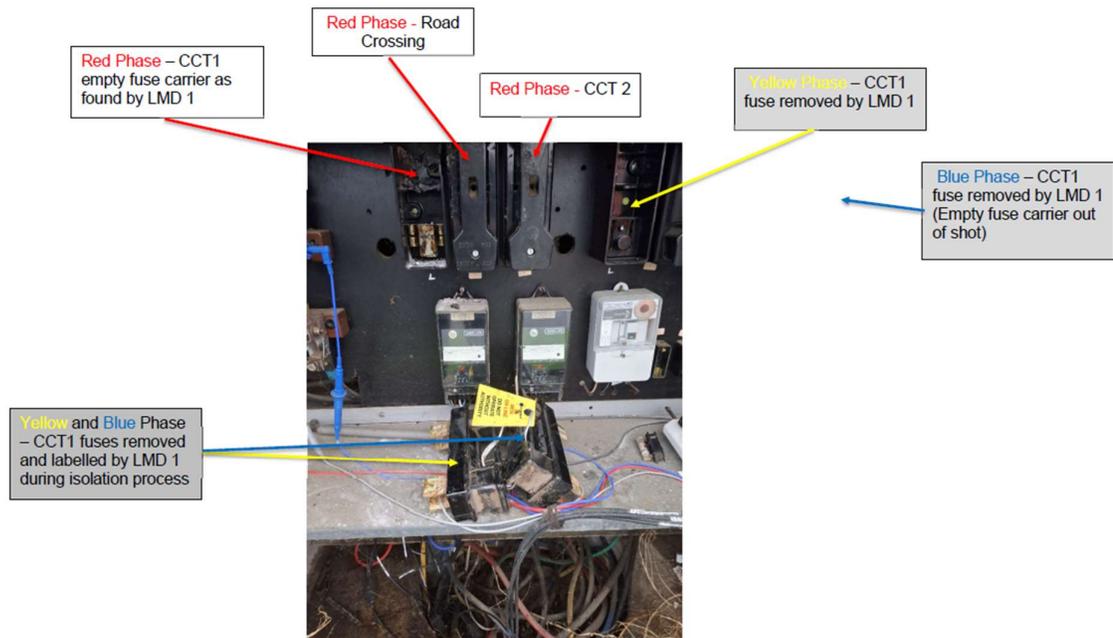
LMD1 identified the transformer isolation point (CCT 2) indicated on the NAPA was incorrect (lights still operating at customers houses after CCT 2 fuses removed) and subsequently removed the yellow and blue phase fuses from CCT 1 – notably the red phase fuse was not present, and the fuse carrier looked burnt out - refer photo 1 below.

Photo 1 - TC4-037 with yellow and blue phase fuse removed from CCT 1 and labelled by LMD1

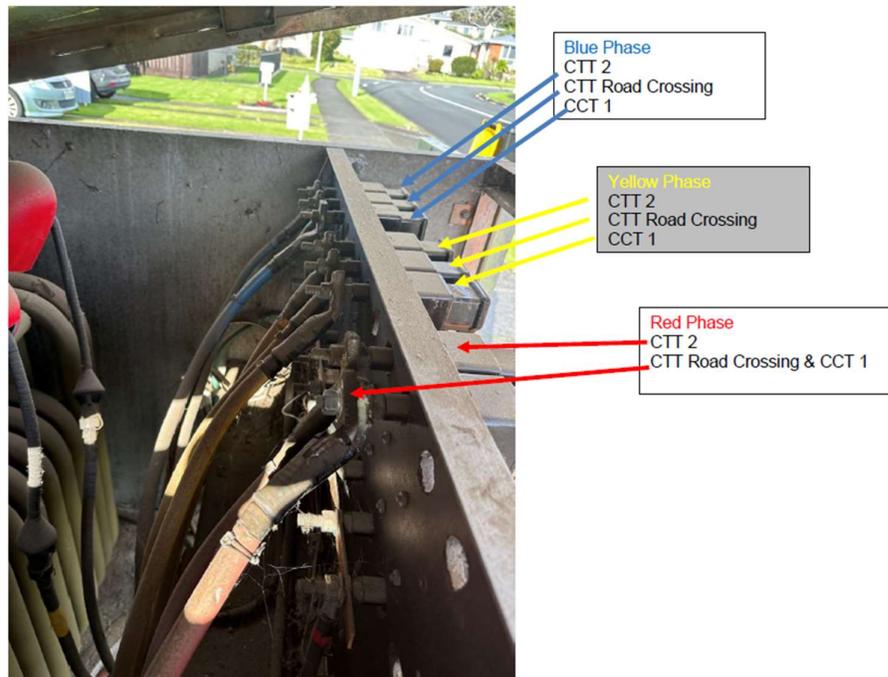
The investigation identified the red phase at the pillar was being fed from the Road Crossing CCT at the transformer after an unknown party had transferred the cable – refer photo 2

Photo 2 - TC4-037 illustrating red phase bonding of CCT 2 and CCT Road Crossing

What to do?	Who	By when
Site made safe - work completed using live methods, defective assets labelled and reported to Powerco	NPE Supervisor	28/05/2025
Communication to employees – the non-negotiable requirement to only use correct testing methods and test equipment to prove isolations	NPE HSEQ Manager	13/06/2025
Communication to employees – re-enforcing empowerment to “Speak Up” and raise concerns beyond immediate work site if required	NPE HSEQ Manager	13/06/2025
Communicate to employees – importance of reporting asset defects/accurate as built information	NPE HSEQ Manager	13/06/2025
Safety Alert issue	NPE HSEQ Manager	09/07/2025
