Secondary Works on Access Permit Isolation Point

A major 220kV Bus Zone protection upgrade is in progress, involving 24 stages and 20 outages across a site with 4 bus sections. The project includes modifying all disconnector secondary mechanism boxes. Due to the high risk of switching multiple bus sections for each modification, the following mitigations were planned:

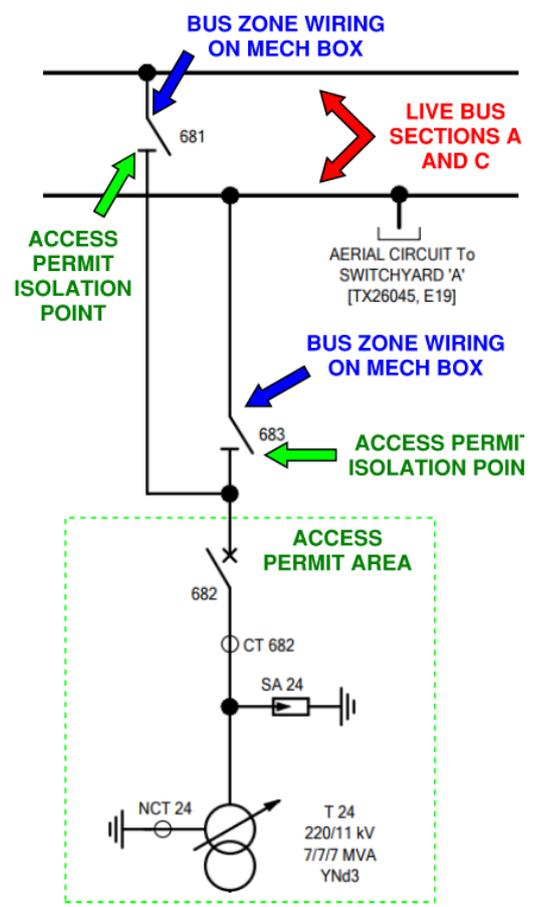
On 24 June 2025, during outage 16, an audit found that disconnectors 681 and 683 were listed as isolation points on an access permit while simultaneously being worked on. This breached TP SS 07.59 Section 10(h), which prohibits any work on equipment used as isolation or earthing points **under any circumstance**.

- ✔ **WMS Review:** The project team reviewed its Work Method Statements and found no changes necessary, confirming the safest overall approach was already in place.
- ✔ **Permit Adjustment:** For the next outage, the project did **not** take out an access permit beyond its own operational requirements, avoiding further conflict with TP SS 07.59 Section 10(h).
- 🔍 **Service Specification Review Initiated:** A review of the wording in **TP SS 07.59 Section 10(h)** has been initiated to address the operational limitations it presents.

The team has subsequently sought and received Regional Service Manager approval to continue using the existing methodology for the remaining project outages, enabling concurrent planned maintenance.
