SAFETY ALERT!

29 July 2025

Excavator not following Safety Protocols in Switchyard

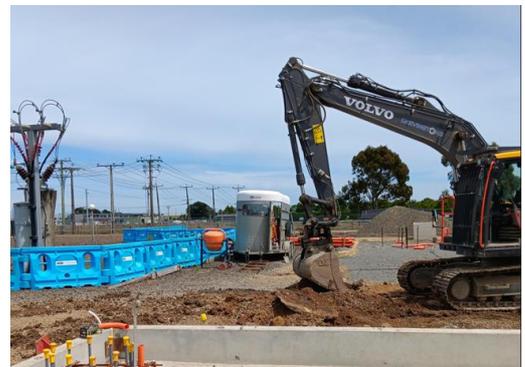
An excavator was observed operating in an exclusion zone of the project construction site without it being earthed and there was no safety observer overseeing the movements of the mobile plant.

- Lack of supervision.
- Ensuring new personnel on site remain in the close supervision of a competent person.
- Absence of clear guidance and boundaries when carrying out tasks in a live switchyard that is reflected in the onsite documentation.

- Paused the job and briefed field work team on mobile plant protocols in live switchyards.
- Earthed the excavator to the substation grid.
- Educated civil construction crew and all site supervisors of the requirements for operating mobile plant safely in switchyards.
- Follow up toolbox talks completed, reiterating contractor internal procedures.
- Regular on-site reviews conducted.

- Ensure adequate supervision is assigned to all work within a live switchyard.
- Regular audits and reviews of safety and equipment procedures/processes must be undertaken to ensure all team members remain compliant with current site rules and protocols.
- New employees are more at risk in the substation environment and therefore always require close supervision until competent.
