SAFETY! ALERT!

30 July 2025

Cut to Finger using a Rattle Gun

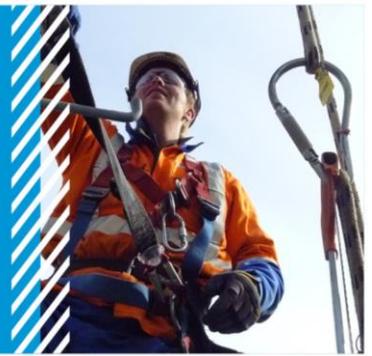
Figure 1 – Typical rattle gun.

Whilst working on the replacement of insulator attachment points, the bottom and top nuts of the double nut arrangement, became wedged in the socket whilst using a rattle gun. This caused the rattle gun to twist, resulting in a cut to a finger. A week of restricted work was prescribed to the worker by the medical provider. The employee returned to work the following day.

- Ensure correct body positioning to avoid being struck.
- Hold tool firmly and with two hands if possible.
- When one person’s capability is exceeded, ensure assistance is acquired.
- Identify all the risks related to the work activities and implement the appropriate controls.
- Ensure all rattle gun users are aware of all the precautionary measures.

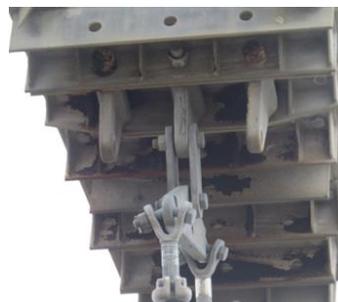
Figure 2 – Insulator attachment points

- Awkward work position to complete the task.
- The hazard of being struck in the hand by a rattle gun was absent from the risk assessment.
