Safety Notice

Notice to Powerco Contractors

Issue 13 | Sep 2025

Transformer base plate / rodent cover

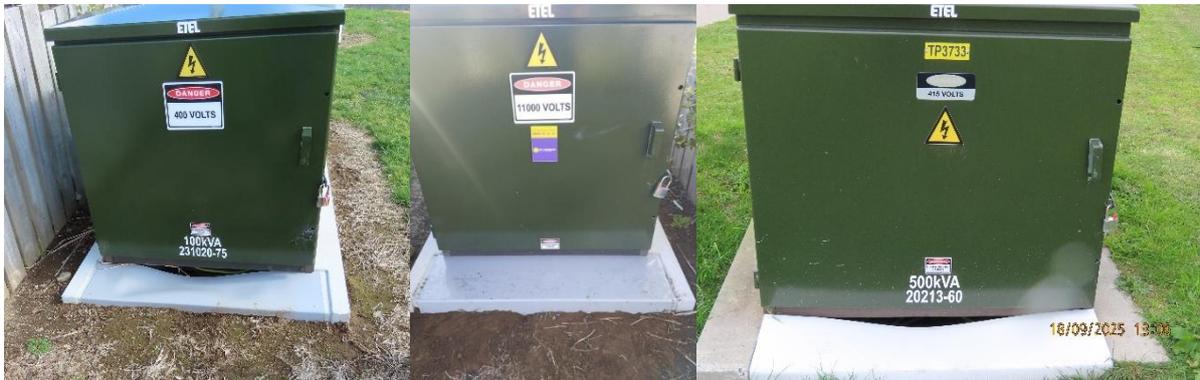
Fig1: Taranaki warped PVC Cover

Fig 2: Replaced cover

Fig 3: Papamoa warped PVC Cover

A recent inspection in South Taranaki (TX 5748E) found the PVC rodent-proof cover on a Busck concrete 'H'-shaped pad had warped inward.

Follow-up checks show 62% of 160 similar transformers across the network have the same issue.

This poses a public safety risk—HV and LV cables may be exposed, and animals can access and damage equipment.

- Thin PVC covers (4.2mm) lacking UV/heat stability.
- Incorrect installation of thicker (6mm) ribbed covers—ribs cut off or not fitted under the TX body.

- Use ribbed/stiffened 6mm PVC covers or an earthed metallic cover.
- Report warped covers with gaps $\geq 5\text{--}10\text{mm}$ via the defect notice process.
