## Stoke (STK) 33kV Switchgear Flashover Incident (Rev 2)

# SAFETY ALERT!

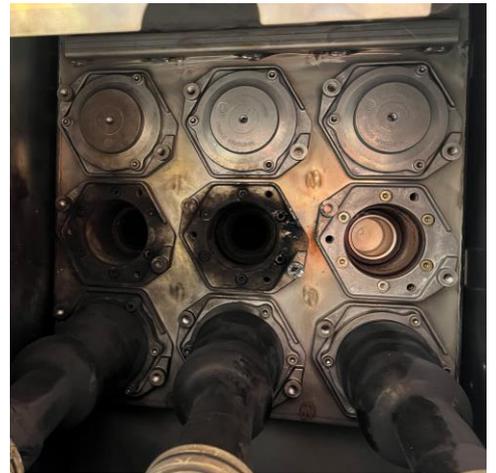
The incident occurred after three dummy plugs were removed live from the inner cone cable termination bushings of Schneider GHA switchgear. The flashover event was initiated by the insertion of a heavy-duty current injection test plug, which caused a blue phase to earth arc flash and then a second concurrent and more intense flashover from the blue phase across to the exposed yellow phase bushing.

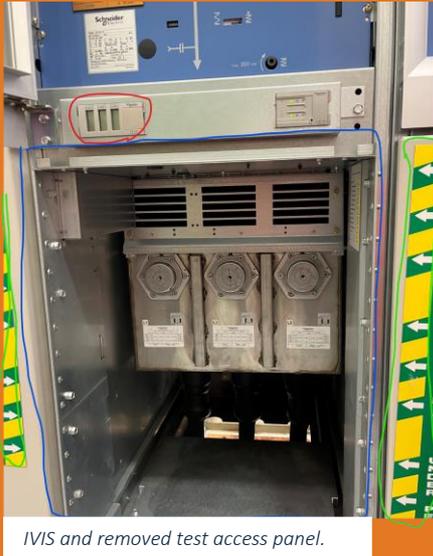
IVIS and removed test access panel.

- The **only approved method** for proving that GHA switchgear is de-energised is via the manufacturer installed Intelligent Voltage Information System (IVIS).

- All test plans for GHA switchgear shall clearly identify that the test access panel cover must be removed for the duration of any testing, regardless of testing injection location. If access from the basement is necessary, a positive identification is required by seeing the removed test access panel from the basement after the cable gland plate has been removed.

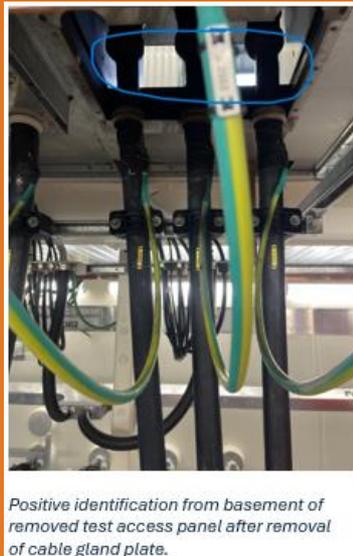
Positive identification from basement of removed test access panel after removal of cable gland plate.

- For GHA gear the test panel is currently the best location to test from and a removed panel is visible from basement (after removal of cable gland plate)

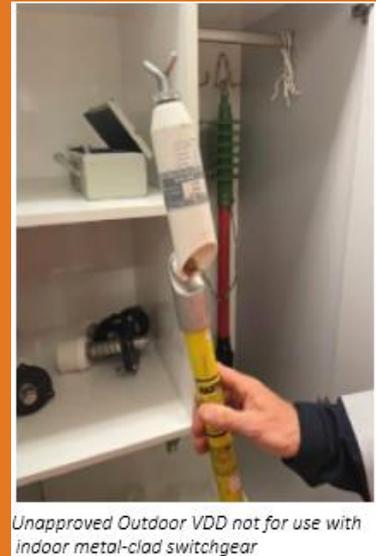
Unapproved Outdoor VDD not for use with indoor metal-clad switchgear

- A Voltage Detection Device (VDD) is not an approved or safe method of proving de-energised for GHA switchgear.
- All primary injection testing must follow a detailed Test Plan, specific to the switchgear being tested
