MV/LV DISTRIBUTION TRANSFORMERS AND SWITCHGEAR – PEBBLECRETE ASBESTOS RISK

Safety notice

Issue 14 | Rev 0 | October 2025

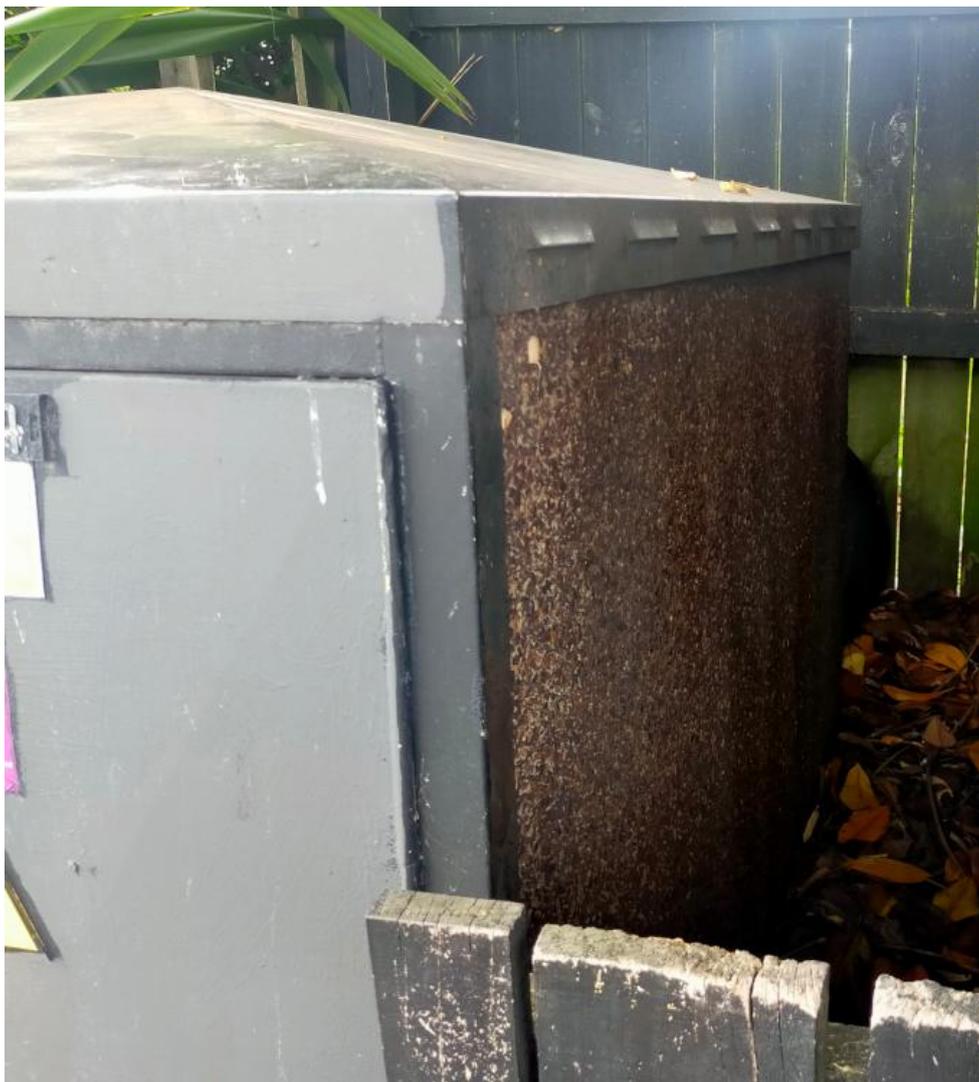
One of Powerco's approved contractors (PAC) suspected asbestos containing material (ACM) during works at one of the abovementioned sites. Testing confirmed the presence of ACM in some pebblecrete enclosures.

Figure 1. Exterior pebblecrete material on kiosk/enclosures

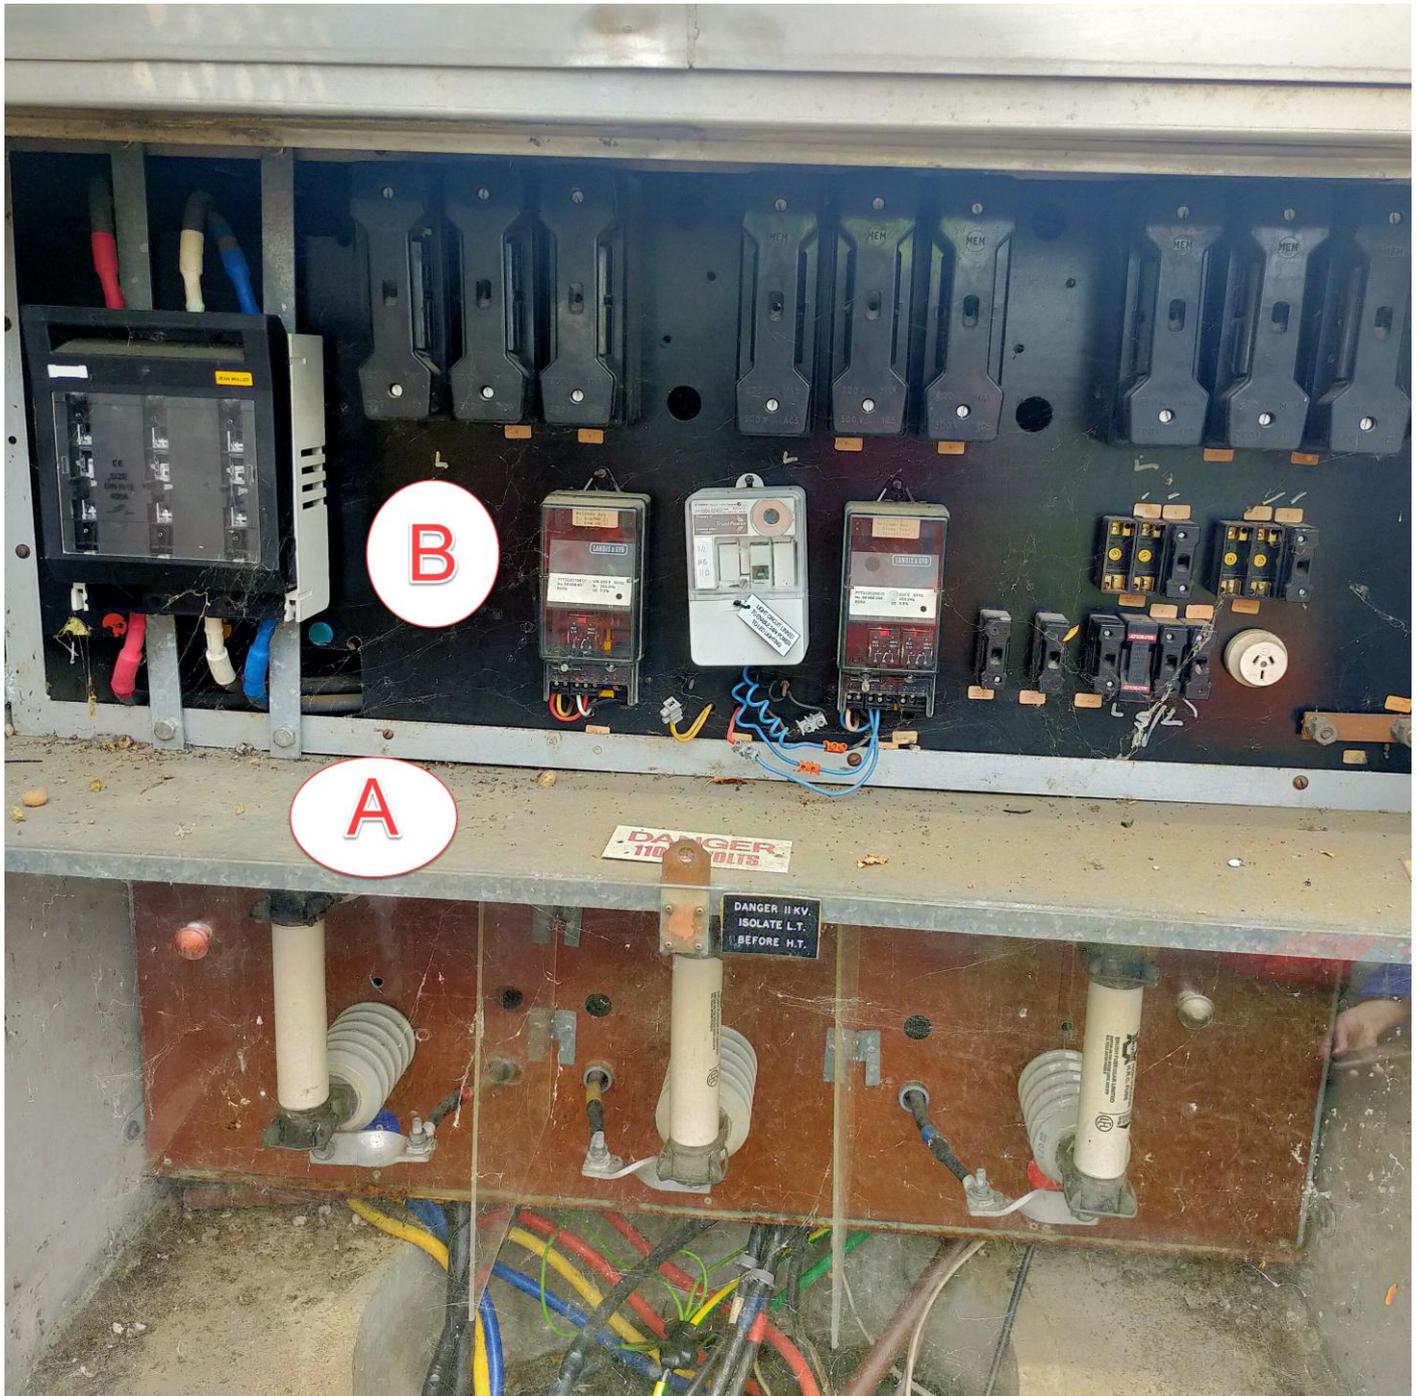
The confirmed ACM was located in two specific areas:

1. The black bituminous boards within the kiosk, typically having LV fusing mounted. This is non-friable and the fibre release potential is very low. **If works are to be carried out on the board it should be removed by a Class B licenced removalist prior to continuing any further work.**
2. There is a metal shelf separating the LV and HV circuits within the kiosk. It is possible in some instances for the metal shelf to have a white board within/under the metal. This material is friable and the fibre release potential is high. **If works are to be carried out anywhere within the kiosk it should be removed by a Class A licenced removalist prior to continuing any further work.**

Figure 1. (B) indicates the bituminous board – low risk and (A) indicates the metal shelf position – high risk (Not all metal shelves have ACM within).

- There are numerous sites containing the black bituminous boards. The class A or class B processes should be followed where intrusive works are being carried out only ie. Work is being done on the board directly, drilling, replacement and removal.
- Not all pebblecrete kiosks have metal shelves containing the white ACM board. The process flows on pages 5-7 of this Notice **must** be followed when the ACM status is unknown or it is known that Class A or B asbestos is present.
- Any licensed asbestos removal company may be used to send photos or video for review.
- Upon completion of any testing, the result must be forwarded to Virotech to update the Powerco asbestos register.
- The register will include all sites that have indicated ACM present, even if the material has been removed and cleaned. QR codes will be affixed to the kiosk, enclosure or room.

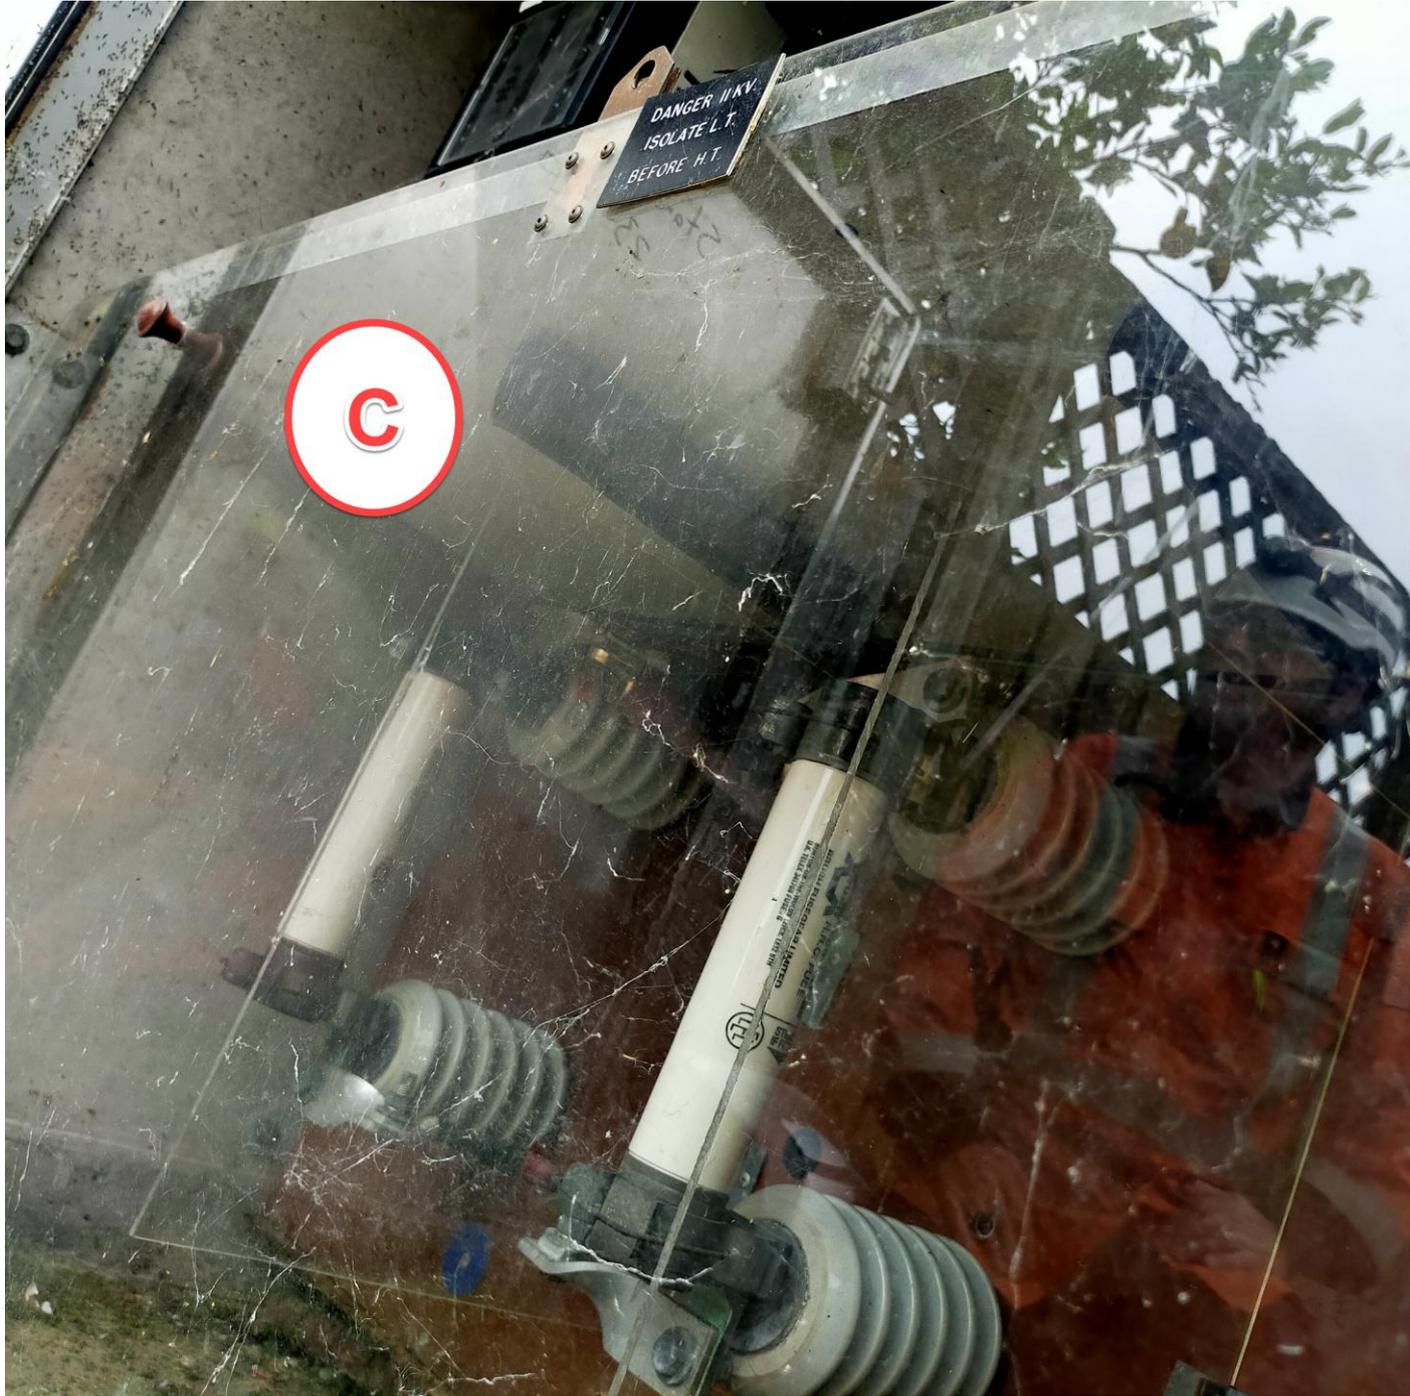
Figure 2. (C) indicates the position of the ACM beneath the metal shelf – high risk
