## FIRST ALERT

### Tethering ladders prior to climbing

Omexom NZ

Event Number: 190945

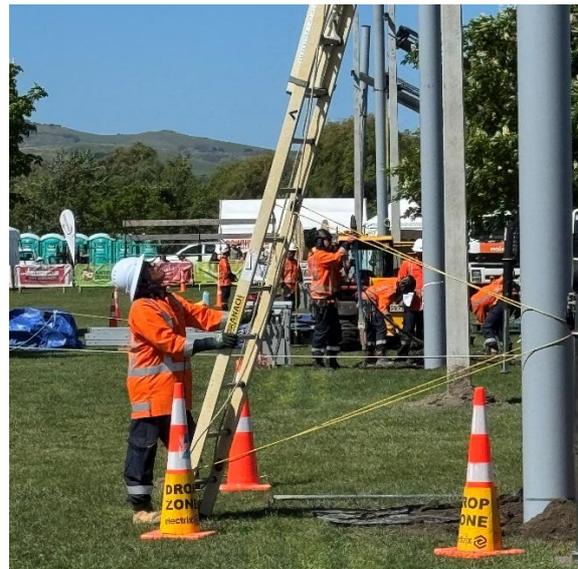
Whilst a line mechanic was descending a ladder that was not tethered or footed, the ladder slipped on a concrete drive. The line mechanic fractured his leg in the incident.

Distribution staff are reminded that a ladder must be tethered to the structure or footed by a second person prior to climbing or descending a ladder.
