## During the slewing movement of a truck mounted access platform part of the basket handrail broke off

<b>Reported date:</b>	11/11/24
<b>Location/site:</b>	OHL Tower ZR 7
<b>Responsible ET dept:</b>	Asset Operations
<b>Principle Contractor:</b>	National Grid
<b>Subcontractor:</b>	Blade Access
<b>Reported by:</b>	Tom Young
<b>Does it relate to a Fatal Risk Group?</b>	Working at Height

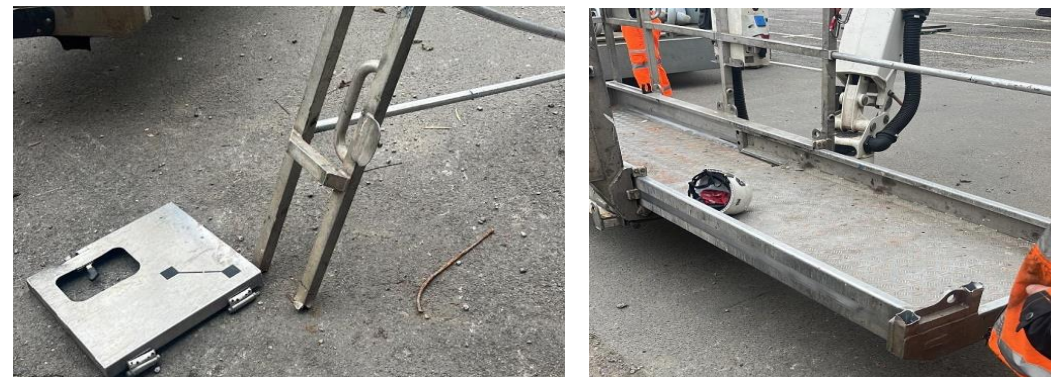
The team were working on the last string of insulators, on the bottom phase, when during a slewing movement there was a loud bang, and the access platform shook violently.

At some point during the slewing movement, the access platform basket had got caught on something, causing the handrail to snap off. The broken handrail fell into the danger zone.

The team believe that it was the chain of the pull lift that got caught on the basket handrail, as this was the only object near the basket.

The incident has highlighted the importance of not only being vigilant but also ensuring that personnel are attached to the correct identified attachment points.
