## Crane Incident at Didcot substation

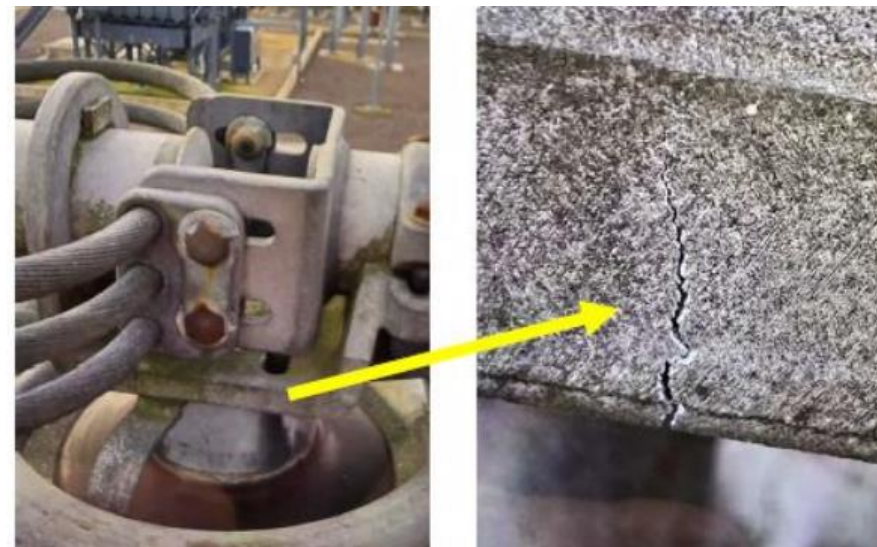
The lift was carried out in a highly confined area with equipment surrounding the crane, including a busbar positioned directly behind the boom. National Grid personnel were operating a MEWP in close proximity, leaving no margin for error or unexpected movement. The crane operator retracted the boom without direct instruction from the lift supervisor, resulting in an impact with an adjacent busbar. No injuries were reported, but damage occurred to the busbar connection.

The operator may have felt pressured to expedite the operation by multitasking, which contributed to the incident and distracted them from ensuring adequate clearance to the busbar.

- Conduct toolbox talks to reinforce the responsibilities of supervisors and lift teams.
- Review and update lift plans and risk assessments to ensure clarity on movement control.
- GGR Group are exploring implementing a 'Code of Conduct' for contract lifts to outline expected behaviours and standard for all operatives.
