IDNO generator back-energised 11kV plant

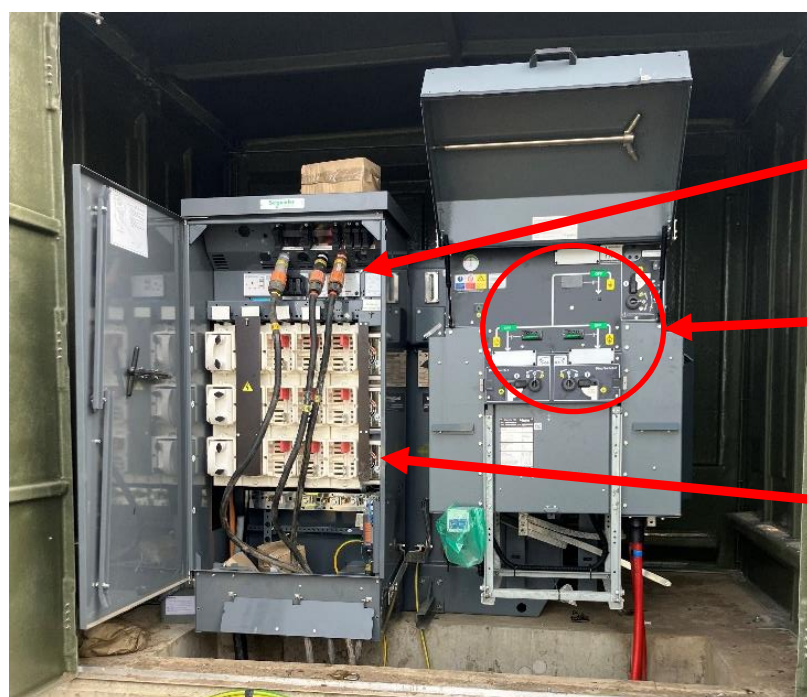
In each case when a SPEN field engineer attended site for handover and to check status of work, the engineer found the generator had been connected to the LV fuseboard but the transformer links were closed, meaning that the transformer was being back-energised. It was fortunate that the 11kV ring switches and circuit breaker were open meaning that the connected cables remained dead – however **there was no point of isolation established**.

Generator connected

HV switches and CB open but not locked

LV transformer links closed

- Always expect the unexpected when receiving handover of third party plant
- Use the SLAM approach – Stop, Look, Assess, Manage
- Although plant may not yet be part of the SPEN system, consider applying Safety Rule precautions in collaboration with the other parties involved to ensure safety during the checking and handover process
- Note that back-energised transformers usually result in the higher voltage having no earth reference which limits the effectiveness of protection systems and also constitutes an ESQCR breach.
