# SHE ALERT

## RTC 1- MEWP Damage

# SHE BRIEF

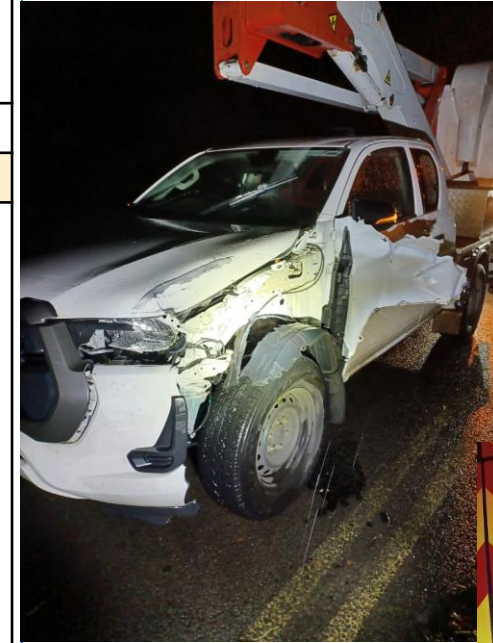
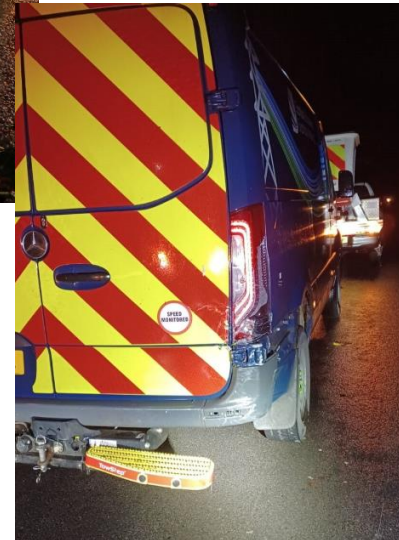
Our colleagues were driving in convoy on the A3 near the Hindhead Tunnel in stormy weather, the leading SSEN Sprinter van hit a large puddle in the slow lane, causing it to slow down sharply. The splash from the puddle created a heavy spray that temporarily blinded the driver of the MEWP following. Struggling to see and trying to avoid a collision, the MEWP driver swerved but hit the back corner of the Sprinter. Both drivers were uninjured and managed to safely pull into a layby further up the A3, where they reported the incident via the 30-minute line, and contacted TM. The MEWP was later recovered to the Petersfield depot.

- Drive to the conditions, Encourage slower speeds and maintain greater stopping distances, particularly when traveling in convoys, adverse weather conditions and in the hours of darkness.
- Pre-plan your journeys to avoid known flooding or high-risk areas.

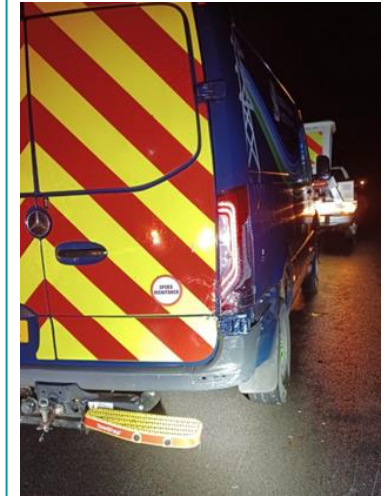
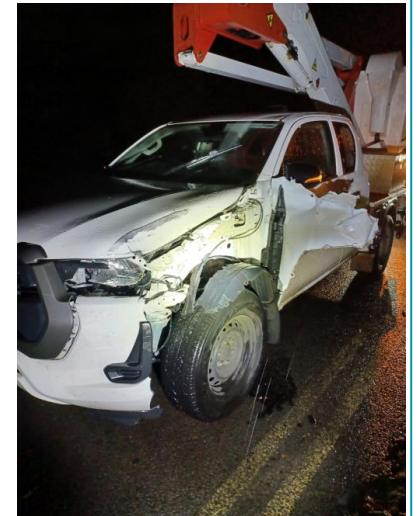
At 22:30 on Sunday, 24th November 2024, during storm Burt, a collision occurred on the northbound A3, just north of the Hindhead tunnel. Heavy rain had pooled across the carriageway, creating hazardous conditions. The team had been working since 11:00 and was travelling in convoy when the tail vehicle, a 4x4 MEWP, was unable to stop in time due to reduced following distance and wet road conditions, resulting in a collision with the lead vehicle.

Adverse weather and pooled water significantly reduced visibility and traction. The following distance was too short for safe reaction time, contributing to the collision. Both drivers were appropriately trained and permitted to drive, with no evidence of time pressure or fatigue as factors. Uneven distribution of navigation systems led to increased reliance on convoy travel.

Following the incident, both drivers completed post-collision training, reinforcing key safety lessons. A SHE investigation confirmed no time pressures and highlighted the need for driving behaviour adjustments. A safety briefing was conducted, covering reduced reliance on convoy travel, safe following distances, speed regulations, and a refresher on the SSEN driver handbook, supported by a video on the two-second rule. Additionally, a navigation system review led to ordering more satellite units to reduce the reliance on convoy travel.

This incident highlights the importance of adjusting driving behaviour for adverse weather conditions, maintaining safe following distances, and proactively managing fatigue, even within working limits. Teams should be equipped with appropriate navigation tools to reduce reliance on convoy travel. When driving in convoy, it is essential to focus on road conditions rather than the lead vehicle to ensure safe reactions. Additionally, extra caution is needed when operating unfamiliar vehicles, as handling and braking distances may differ. This incident reinforces the importance of adaptive driving behaviour and proactive risk management for safer journeys.
