SHE ALERT

Cut Neutral Conductor

SHE BRIEF

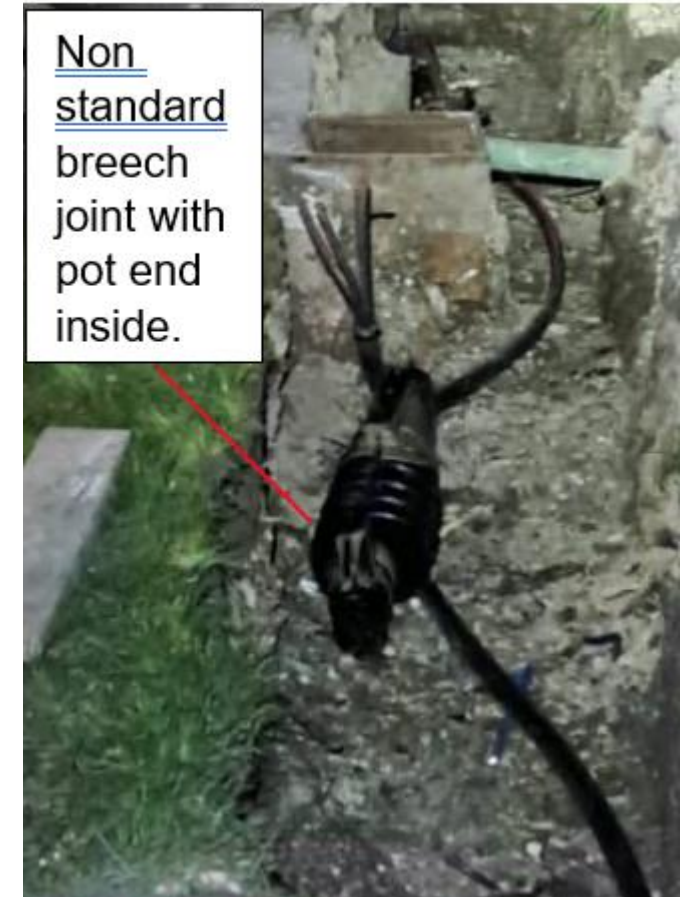
Date of incident	17-03-2025		Directorate	Distribution	
Region	CMI	Location	Marlborough	Classification	EOP
What happened?					
<p>Works were being undertaken to joint out and remove a redundant link box.</p> <p>During the course of the works the neutral conductor was cut while 2 cores were still live, causing supply issues to properties. Full PPE was being worn, and they were no injuries.</p> <p>A full and thorough investigation is underway, and all learning will be shared when this is completed.</p> <p>In the interim staff are reminded to follow work instructions and always adhere to the correct jointing procedures and not deviate from the task.</p> <p>SSEN DMS - SSENLibrary - All Documents</p> <p>If works cannot be completed as planned, then STOP and Escalate any concerns to your line management.</p>

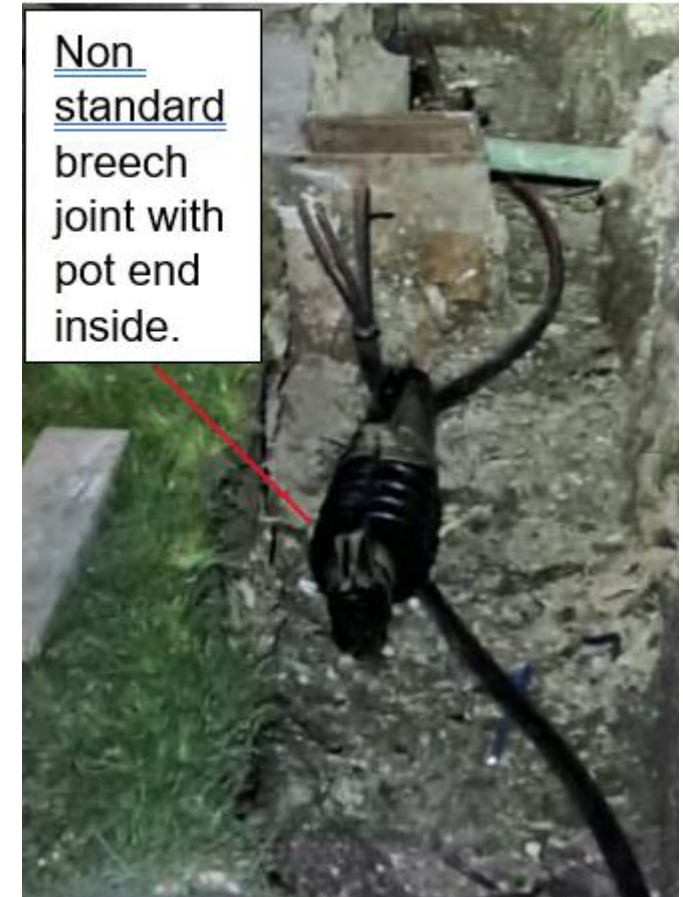
During planned work to remove a redundant link box the neutral conductor was cut while 2 cores were still live, causing damage to several customers property.

The design document had been approved and work pack issued, when the team arrived onsite it was found that the works could not be completed as per the design document. At this point, the work should have stopped and escalated to a manager, but the team took it on themselves to complete the works using a non-standard joint, it was during this procedure the incident happened. Full PPE was being worn, and they were no injuries.

Staff are reminded to following the correct jointing procedure and not deviate from the task.
