## SOP 441 – Prysmian 400kV Cable Terminations – update to RMZ dimensions

This Express supersedes Safety Express EXP-10-579, published in February 2025, which is now withdrawn. The revision in this Express is to the dimensions of the RMZ noted below, from 25m to 30m at Hunterston East.

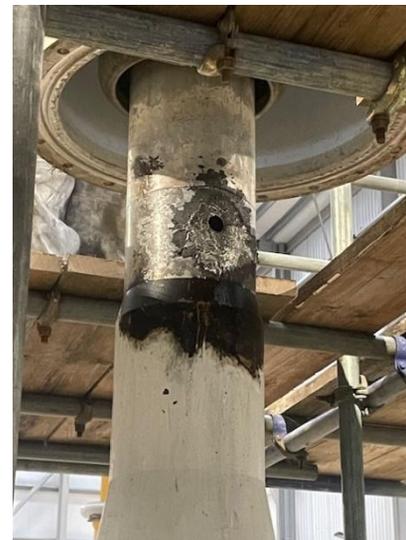
There was a subsequent failure in January 2025 again at Hunterston Converter Station. (Ref: NEDER 2025/1049/00).

Investigation into the root causes of both are still ongoing, however early indications show a contributing factor may be related to past installation works on this specific site. On completion of both investigations an update will follow.

January 2025 Failure Investigation

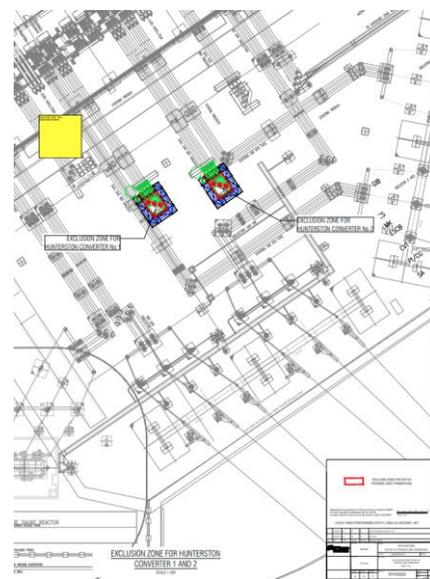
SPEN have taken the decision to update the Risk Management Zone (RMZ). No personnel are to be within a minimum distance of 30m at Hunterston East and 25m at Hunterston Converter Station around all matching cable termination types.

Hunterston East Updated RMZ as per OPSAF-04-026

- SP Transmission to install signage communicating RMZ to all personnel
- It is a requirement to follow processes detailed in [OPSAF-04-026](#) when accessing the Hunterston compound. This document is available only to SPEN staff through the EN Document Library. SPEN Service Partners can request a copy through their nominated SPEN Project Manager
- Screens are to be erected to protect personnel where work is required within the RMZ of the affected terminations
- The investigation to determine the root cause and repairs are ongoing. A further update will follow in due course.
