# SHE ALERT

## Injured Arm

Date of incident	7 <sup>th</sup> June 2025		Directorate	Operations SEPD	
Region	South East	Location	Sandown, IOW	Classification	LTI

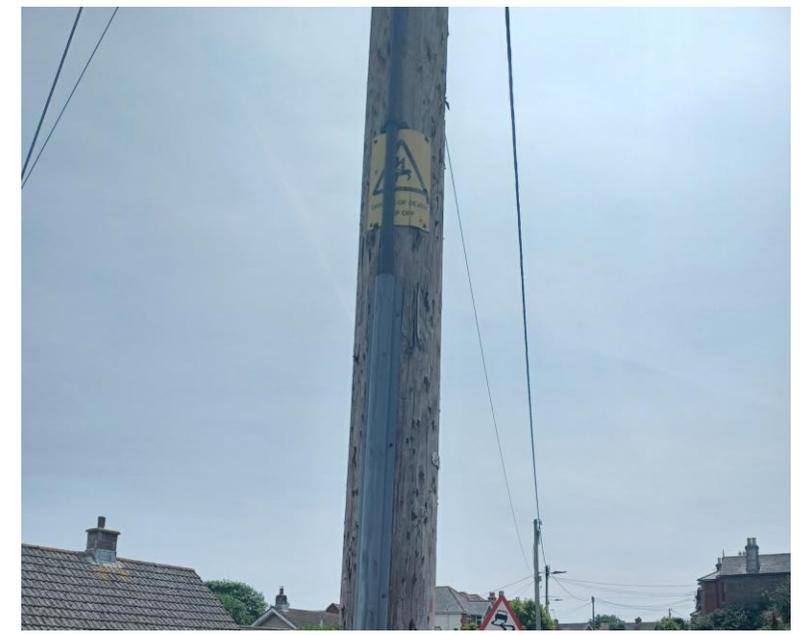
One of our colleagues was descending a Low Voltage (LV) pole after carrying out testing on the overhead line. While descending, the spike on their right leg slipped on the danger sign attached to the pole, and they instinctively reached out with their left arm to prevent a fall. This resulted in an arm injury. Our colleague was taken to hospital, where they were given and prescribed pain relief. They have been advised that an MRI scan will be needed to determine the extent of the injury, which is scheduled to take place within the next two weeks.

- Always ensure the correct Working at Height procedure is followed [RS-SHE-105 Working at Height](#)
- Use the working at height risk card [CA-SHE-105-001 Working at Height](#)
