SHE ALERT

Contractor Thumb Injury

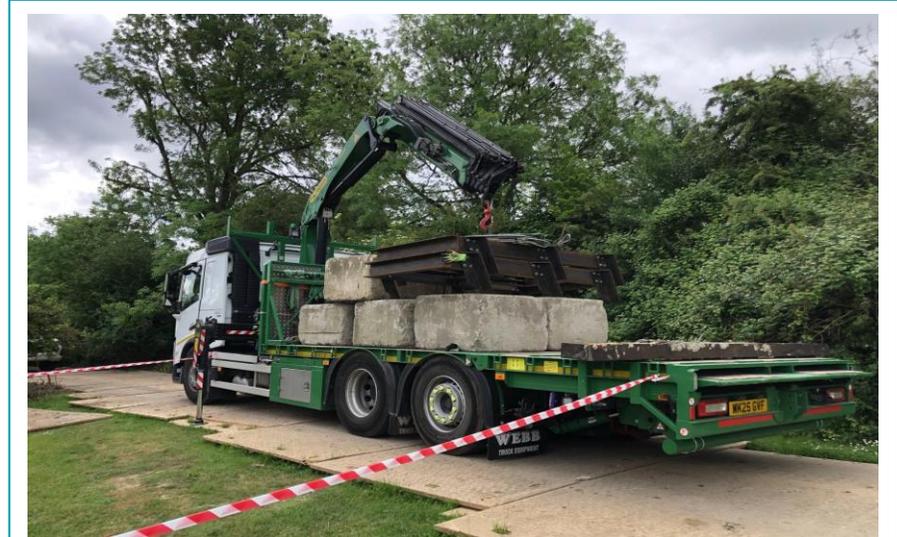
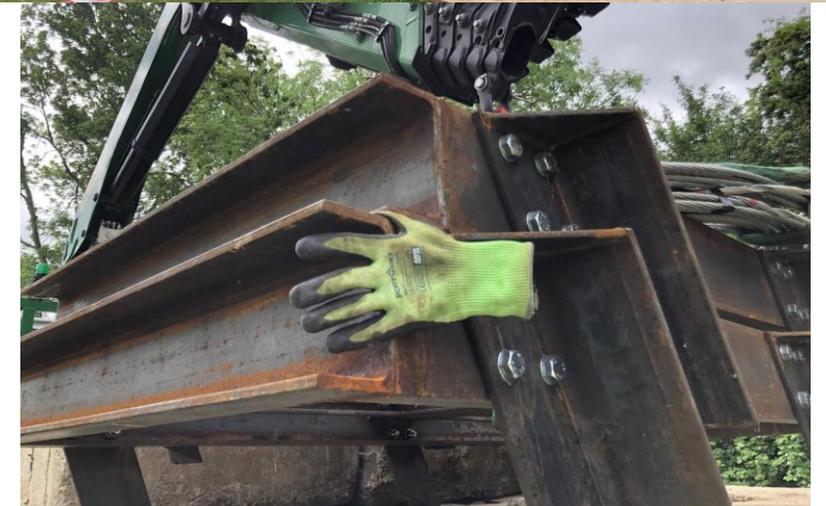
Date of incident	29 th May 2025		Directorate	Operations SEPD	
Region	CMI	Location	Drayton	Classification	RIDDOR
What happened?					
<p>The team was required to lift eight concrete blocks and two sledges (heavy metal temporary stay holders). The team had successfully lifted all eight concrete blocks using the Hiab and were in the process of loading the sledges onto the concrete blocks as a stack.</p> <p>As the load was being positioned on the Hiab, the IP placed their hand to guide it into position, where the first sledge rested on the concrete blocks, the second sledge stack slipped down and trapped the IP's thumb between two metal plates. The team immediately stopped work, and the bank's person used a first aid kit to bandage the wound and reported the incident to their supervisor.</p> <p>While we investigate, please remember the below:</p> <ul style="list-style-type: none"> • Keep out of the line of fire. • Use a tag line when moving equipment around. • Do not enter the back of a lorry with out edge protection.
