# SHE ALERT

## Contractor Potential To Be Worse

| Date of incident | 18 June 2025 | | Directorate | Large Capital Delivery | |
| Region | SEPD | Location | Derby Rd, Southampton | Classification | PTBW |

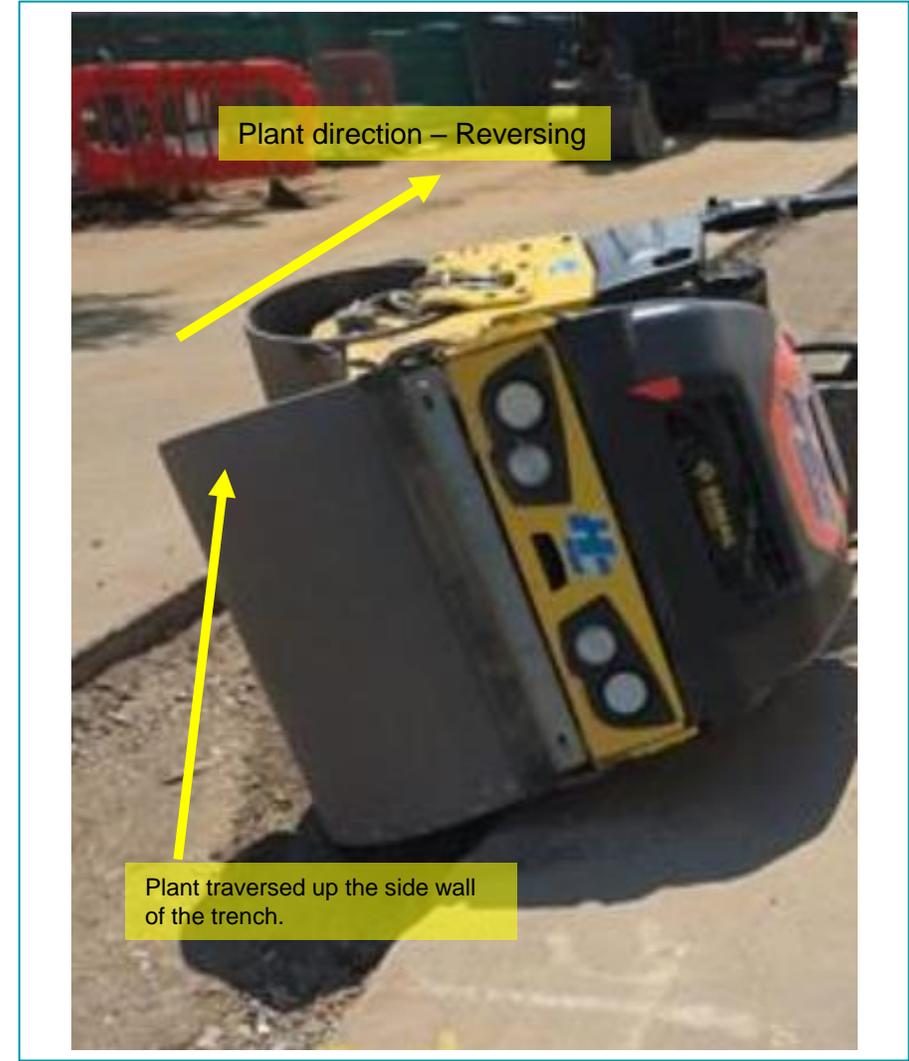
| <p>A Contract Partner (CP) plant operator (PO) was compacting the last layer recycled Type 1 in the trench (150mm below finished level), the trench diameters (W 1000mm, H 89-101mm) Roller width (800mm), The CP PO overcompensated the steering whilst reversing when the CP PO potentially hit a high spot on the edge of trench. The plant traversed up the side wall and overturned, their left leg was out of the foothold. The CP PO proceeded to undo the seat belt to exit the roller.</p> <p>The Injured Person (IP) sustained an injury to their right calf; The IP was given first aid onsite and taken to the local A&amp;E by ambulance.</p> <p>The Plant was left in situ and the area secured and barricaded off. A full investigation is ongoing, and the findings will be reported in the B brief.</p> <p><b>Initial Learnings to consider:</b></p> <ul style="list-style-type: none"><li>• Plan scan and adapt to the ever-changing work conditions/environment</li><li>• Carry out 20 second scans of the work zone</li><li>• A thorough risk assessment should always be completed, reviewing all potential hazards and control measures</li><li>• Review plant operational requirements, risk assessments and identify the correct plant for the task.</li></ul> <p>Please review the <a href="#">Dynamic Risk Assessment SATT</a> and Plan, Scan and Adapt - SSE <a href="#">Plan Scan Adapt 2024v3</a></p> | | | | | |
