SHE ALERT

LV Flashover

Date of incident:	10/11/2025		Directorate	Services SHEPD	
Region	Customer Operations	Location	Perth	Classification	Potential to be Worse
What happened ?					
<p>Our colleague attended site to carry out a Low Voltage (LV) 1ph service straight joint.</p> <p>On entering the joint bay and beginning the service connection works, our colleague began to strip the outer sheath of the 1ph service cable when an electrical flashover occurred, the event resulted in a burn to their left thumb.</p> <p>First aid was administered at the scene, where a cooling gel pack was used. The injured party(IP) was then taken to hospital where the burn was cleaned and dressed and thereafter was released with no further medical treatment.</p> <p>As we investigate the incident further, please consider the following while carrying out LIVE Jointing works:</p> <p>Operational Safety Manual - Operational Safety Manual – SSEN</p> <p style="text-align: center;">Utilise your safety licence. If it's not safe we don't do it!</p>

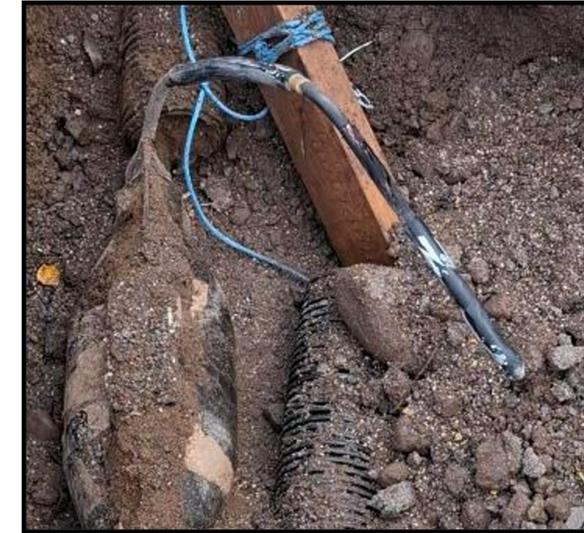
Service Potend & Damaged Service Cable

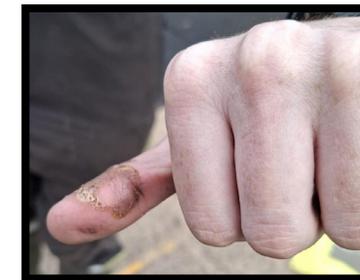
Burn to AP's thumb
