FIRST ALERT

Wilton PDL56 Series 230V 15A Outlet Flashover

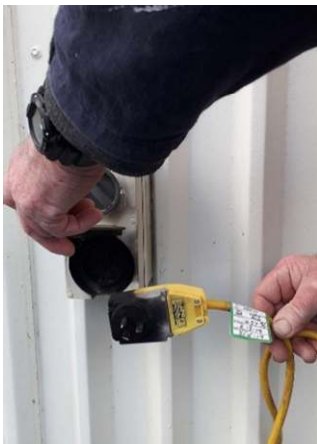
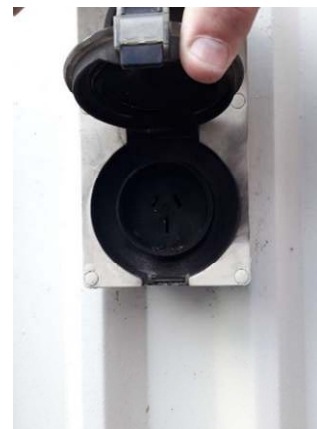
On the 2nd of May 2019, a suspected failure of the PDL56 series 15A outlet resulted in a flashover and a loss of the site 400V supply at Wilton.

3. The PDL56 outlet is badly damaged, but indication strongly suggests a failure of the PDL56 outlet. The outlet is 20 years old and located outside. Signs indicate moisture/condensation present inside switch leading to flashover. Team to check electrical condition of older outdoor outlets.
