Induced Voltages

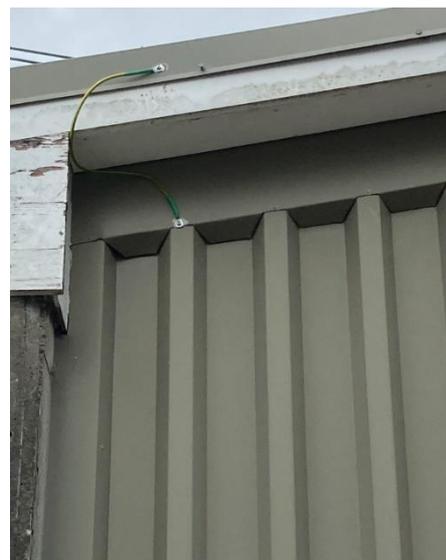
A building sub-contractor working on the FM contract touched a metallic spouting while measuring up for future spouting replacement. The building involved was the Hayward's 11kV switch room located within the Haywards-DC Outdoor 220kV Switchyard. The subcontractor was utilising a fibreglass ladder at the time and received an electric shock. Weather conditions were heavily overcast.

The individual thought the electricity build-up had been discharged but when his arm brushed the spouting again, he received a second shock. He immediately descended the ladder and ceased further work.

Subsequent investigation's by Ventia substation maintenance staff established that the electric shock was due to voltage being induced by the surrounding high voltage electrical equipment

- All further elevated work within the ODS at Haywards needs to be carried out in consultation with the Station Maintenance Service Provider, and where necessary, additional bonding be provided to mitigate against any measured induced voltages.
- Engage the Station Maintenance Service Provider to permanently bond the spouting on the 11kV switch room building.
