FIRST ALERT

12 January 2021

33kV Porcelain Cable Termination Failure

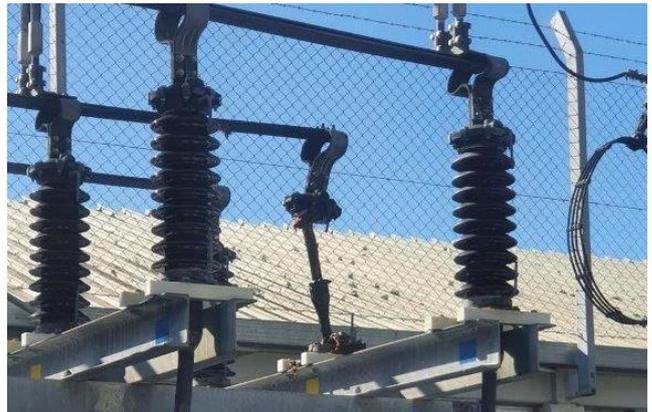
On the 15th of December 2020 a 33kV porcelain cable termination failed explosively at Gracefield substation causing one of the supply transformers to trip.

Porcelain fragments and sealing compound spread up to 25 meters away from the source. No personnel were at the substation at the time. The photo below shows the failed termination and similar remaining terminations.

The root cause of this failure is unknown at this stage, but a forensic investigation will be conducted in the coming months. The only known instances of this model of termination are at Gracefield substation.

- An exclusion zone was created around similar terminations which were still in service.
- The terminations on the faulted circuit were replaced with modern polymer cable terminations.

Everyone working near these terminations should exercise caution and ensure that safety plans and work plans consider the elevated risk. We recommend the following precautionary steps be taken:

- Where terminations are located closer than 25m to project works where personnel are working, then personnel should minimize the time spent within this zone.
- If personnel have no reason to be closer than 25m from these terminations, they should keep clear. This exclusion zone information should be entered on the site temporary hazard board.
- Where the terminations are located within 25m of the boundary and where the public/personnel can access the adjacent area, then the fence should have shade cloth, or industrial plastic, or some other suitable materials put in place along the fence line to stop any debris should a termination fail.

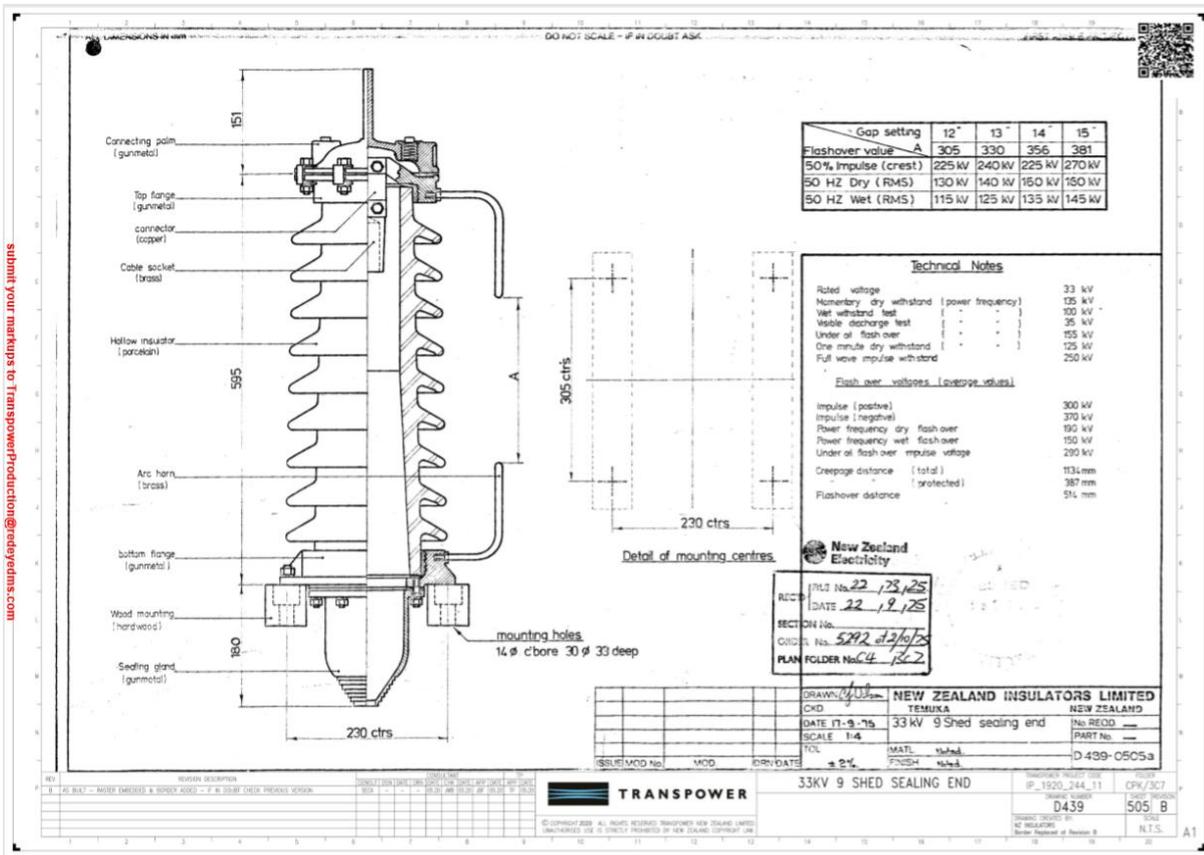
There may be similar terminations on Transpower's network, however this data is not comprehensively captured in MAXIMO. If you are aware of other locations where this model of termination is installed, please inform Operational Engineering. The model of the termination was a New Zealand Insulators 33kV 9 Shed Sealing End. A technical drawing is on the following page.
