Wanganui – Primary Current Injection on CT92 Tripped the 110kV Bus

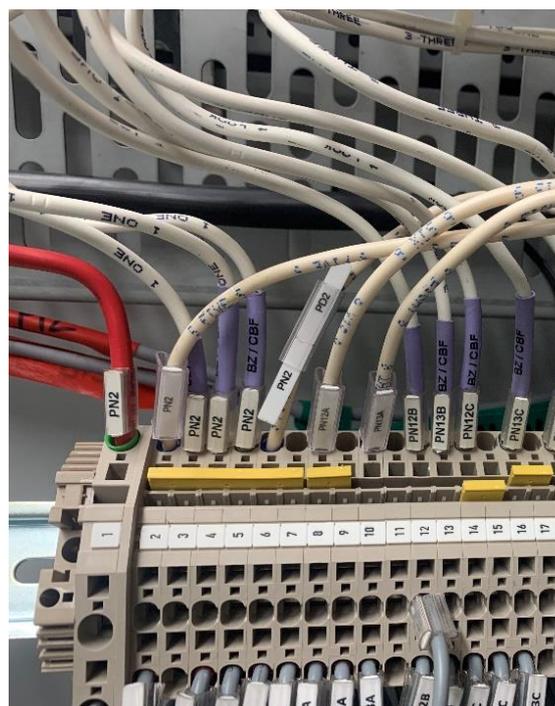
- During a staged project the 110kV bus at Wanganui tripped while primary current injection testing was being undertaken to prove the AC wiring to the new (CB92) Protection 2 Relay.
- This was caused by an unexpected CB Fail Initiate, thus tripping the 110kV bus.

- The 110kV bus was out of service for approximately 20 minutes.
- Supply was restored at approximately 8am.
- No personal injury or damage to assets was sustained.

- Notified Transpower Project Manager, NGOC, Electrix Management, Electrix Project Manager and Contract Engineer.
- Checked to confirm there was no damage to equipment.
- Restored 110kV Bus.
- Completed initial investigation which established that the new CB Fail Initiate cable and wiring had been terminated earlier than indicated on the project plan.
- Initiated further investigation to determine the sequence of events, and any other contributing factors to the incident.
