## Wanganui 110kV Bus Tripping

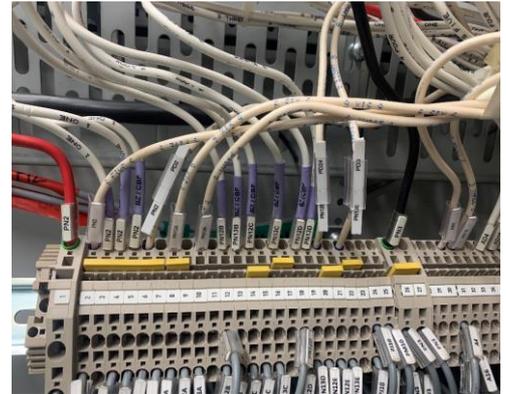
- During primary current injection testing to prove the AC wiring to the new Protection 2 Relay (BPE-WGN CCT1 CB92), the 110kV bus was tripped via the CBFail scheme. There is currently only one "Zone" on the 110kV bus.
- The project was a staged project and a new cable was required for the CBFail initiate circuits from the new Protection 2 and the future Bus Zone. This cable was to be terminated during the CBFail outage. The cable was however, terminated at both ends before the intended CBFail outage, resulting in the tripping when primary injection commenced.

The correct date for termination was identified during the planning phase of the project, this information was clearly recorded on the cable termination cards and displayed on the protection panel door. The cable however was terminated without recognising the significance of these dates.

- It is important that all parties are clear on project sequencing and when cables are to be terminated. Controls such as notes on cable cards and indications on the panel door are additional control measures, however misunderstandings can still arise.
- To reduce the chances of incorrect sequencing of activities, project briefings, Work Method Statements AND close communication with Technicians is required. This is extremely important before undertaking any work in a Bus Zone or CBFail panel.
