Safety Advisory

Cracks in welded crane connections

Palfinger New Zealand SERVICE INFORMATION

PALFINGER
C-11/2020

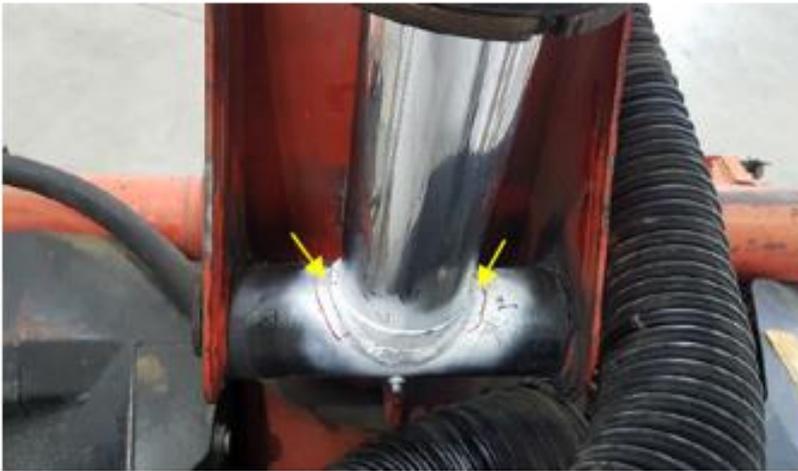
Inspections of our relevant fleet started last week. The cracks can initially be identified by a slight rusting in the crease of the welded boss area as indicated in image shown in the Palfinger NZ’s Service Information sheet.

In the last few days, we have been made aware of small cracks appearing in the welded connection between the piston rod and the mounting boss on the main lift and outer boom cylinders on a small number of cranes.

Even though we are still unsure of the root cause, the cracks found to date appear to be fatigue or stress fractures and we do not believe they propose an immediate concern for a catastrophic failure.

Below is an example of a recent unit that was crack tested showing the area of concern.

- All cranes in your fleet are to be checked for signs of cracks appearing in the welded connection between the piston rod and the mounting boss on the main lift and outer boom cylinders.

- Mark the limits of the crack with a permanent marker to monitor any growth.
 - Inform all crane operators of the issue, and if their crane has been identified to have a crack advise them to:

This area of the main and outer lift cylinders should be inspected as part of any routine service and especially part of the routine annual inspection and certification process which should be performed by an approved inspection body.
