Excavator slide

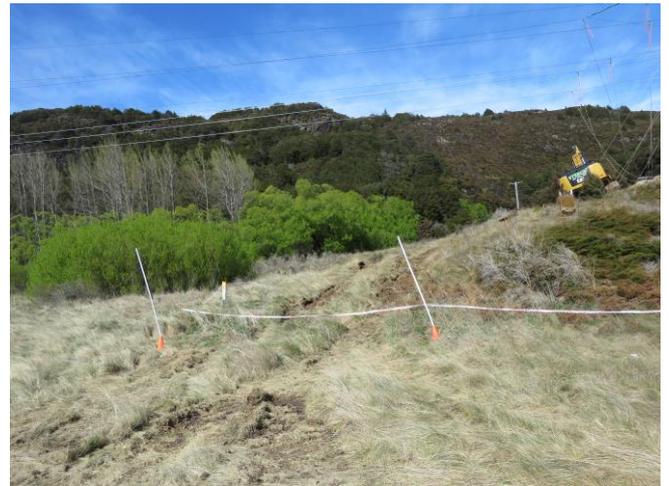
An excavator was traversing down the side of a slope under an Orion 11kv overhead line and slid approximately 1.5m on the wet grass. The boom of the machine swung and encroached the MAD of the Orion line. A safety observer was present, and barriers and warning signs were also installed underneath the overhead line.

The access being used was not one of the initial routes agreed on in the job planning. However, the machine became 'trapped' by the site works and it was decided to use this alternate route as an accessway. The line clearance was tight even in ideal conditions and a flatter route was available by removing a section of fence.

- The machine was stopped and the site assessed
- A different access way was used from then on
- Transpower and Orion were notified

- Use the safest route even if it takes longer
- Obtain a MAA if the MAD cannot be guaranteed
