Tibia Fracture Above Ankle

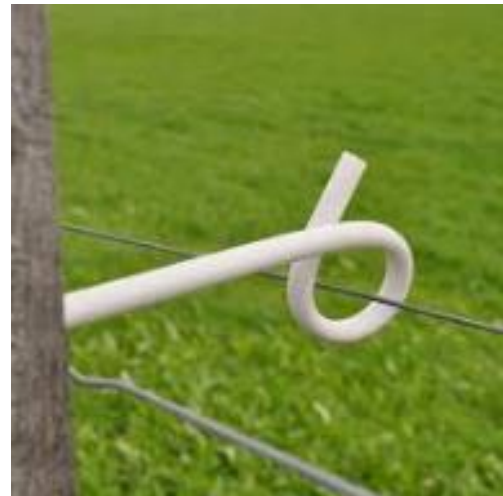
As they crossed the first paddock they encountered a wire fence. Normal practice would be to climb up one side and down the other, but this fence had a hot wire on one side with a nominal 300mm standoff. They had to climb to the top of fence and jump down over the hot wire. This occurred without incident. On their return crossing this fence one team member landed awkwardly when he jumped down and sustained a fracture to the right tibia.

- When accessing properties, mapped/ formed tracks should be used where possible even if this means not taking the most direct route to the work site. It is better to walk further and use available gate ways rather than climb fences
- Climbing of fences should be avoided where possible especially those with electric fence attachments. If fences with hot wires must be climbed, then mitigations should be put in place.
- Possible mitigations include the use of electric fence testers to check if the hot wire is live and placing non-conductive covers over the live wire/tape to protect against electric shock.
