Safety Alert

Orion

SA2415 Critical Risk – Uncontrolled Energy Release - Electricity Operating the Low Voltage Network

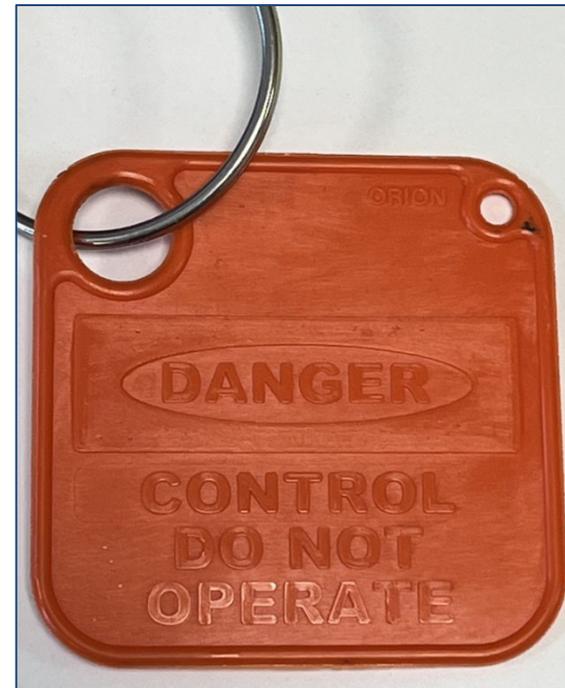
A contractor removed an Orion Control Tag and closed an LV isolation point. They believed they needed to complete this step to liven the LV panel before the new circuits could be livened.

This was not an authorised item and could have resulted in someone being exposed to live electrical sources.

The switching steps to complete the commissioning and livening were agreed verbally between two contractor operators and an Orion control shroud and tag was removed (only an Orion Control issued operating order can authorise this action).

- Orion Contract Manager working with the Contractor to review and provided support through the investigation and corrective action process
- Issuing this Safety Alert – for information and discussion
- Notifying Orion staff, in particular Connection and Contract Delivery Managers
- Engaging with our service delivery partners to heighten their awareness
