# FIRST ALERT

## Earth Bond not Applied

Business Unit: Omexom Transmission Projects

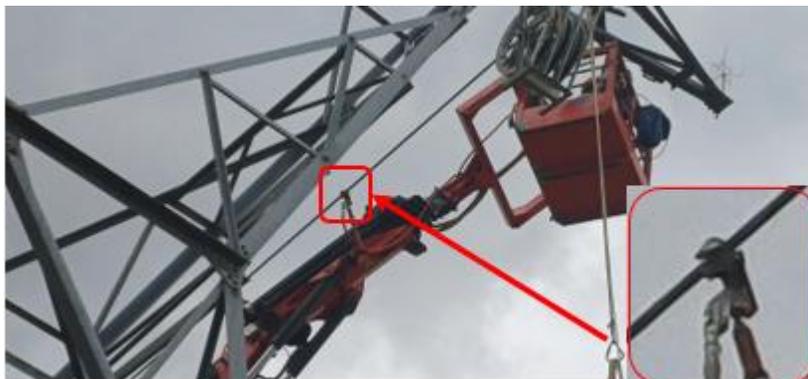
Line Mechanics working from a man-cage, within 5 metres of a set of three-phase earths, had not applied an earth bond from the man-cage to the appropriate conductor.

*Picture - showing the applied bond*

On realisation, the earth bond was applied immediately to the man-cage and used appropriately.
