SAFETY ALERT!

19 January 2026

Impact Injury

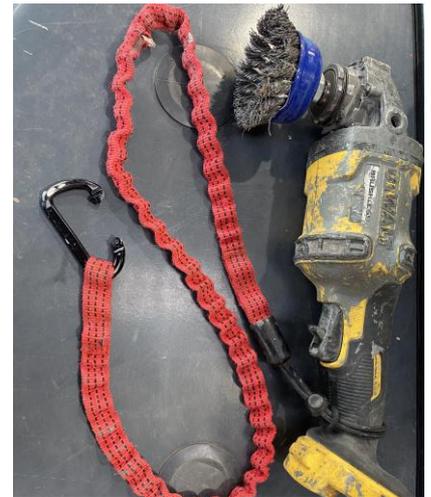
During the task, they disconnected the tool tether from their harness as the tool was running. As a result, the tether and attached carabiner contacted the rotating grinder wheel. The carabiner was propelled at high speed and struck the Tower Structure Maintainer's thumb, causing the laceration and a fracture.

Fig 1: Grinder with attached tool lanyard and carabiner

The investigation concluded that the worker did not follow the procedure which is to tether all tools when working aloft. The basic cause is the repositioning of the tool while running and rotating, causing it to catch on the carabiner.

- Verify that all portable equipment is securely tethered prior to use.
- Ensure work positioning on the tower allows controlled movement when operating portable equipment.
- Confirm that the tool tether carabiner is securely attached to the worker's harness or an approved tower attachment point before commencing work.
- Clear instructions for the use of portable equipment during the daily toolbox meetings and risk
