# Safety Alert

## SA2417 – Critical Risk – Uncontrolled Energy Release - Electricity

A Service Delivery Partner (SDP) employee received an electric shock while working on a battery charger supply circuit within a building substation.

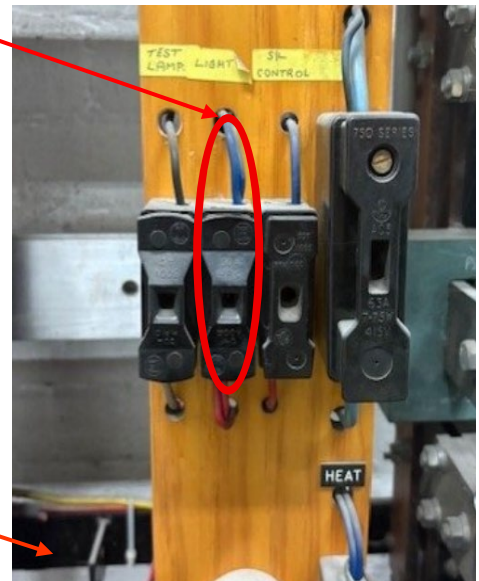
- An isolation point was available but not used.
- Circuit supplying battery charger was labelled 'Light' at the Low Voltage (LV) panel. (Photo A),
- The circuit was isolated at the local battery charger connection point (not at the fuse installed on the LV panel). (Photo B).
- When the decision not to isolate was made, Live Work processes were not initiated.

**Photo A**  
Battery charger  
isolation fuse (centre)  
labelled 'Light'

- **Identify the circuit** to be worked on,
- **Isolate the circuit** at the appropriate point of isolation. (**Prove, Test, Prove**)
- If **live work** is to occur, live work protocols must be followed.

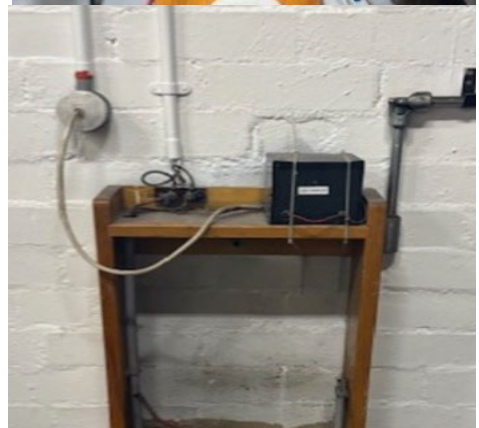
**Photo B**  
Point of isolation  
used for the battery  
charger
