# FIRST ALERT

## Transmission line mechanic received an induction shock when repositioning an earth lead

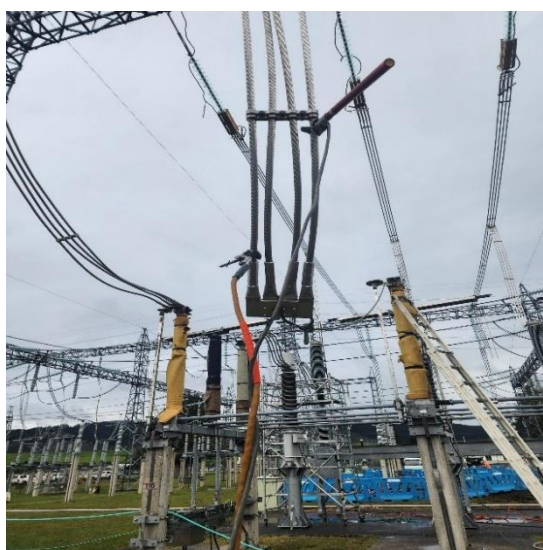
A transmission line mechanic received an induction shock while completing the installation of droppers from a transmission line terminal span to a disconnecter/earth switch arrangement. The incident occurred when the worker was repositioning an earth lead, transferring the earth lead head from the right-hand side to the left-hand side of the jumper.

- The team were immediately stood down.
- The worker was taken to hospital for precautionary check-up. They were cleared and returned to work.
- Prior to work continuing the team were refreshed on both the stations and transmission lines equipotential bonding and earthing of associated equipment procedures.
- ICAM investigation initiated to determine the root cause and any other contributing factors to be addressed.
