## EWP Insulated Bucket Hazard

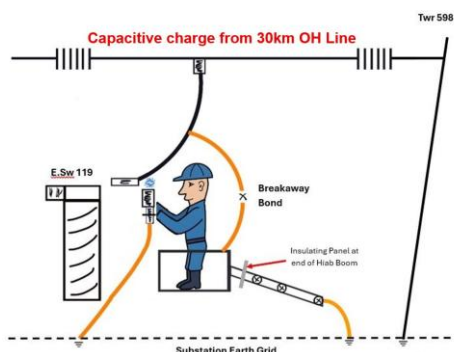
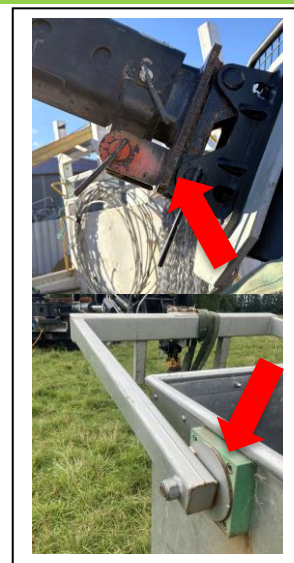
A transmission line mechanic received an induction shock while repositioning a portable earth on a de-energised transmission line.

The investigation identified an unrecognised insulated panel fitted between the EWP boom and personnel bucket. This insulated component prevented the worker and bucket from

remaining within the intended equipotential zone, allowing a voltage difference to develop and resulting in an induction shock when contact was made with a portable earth connected to the substation earth grid.

Potential consequence: Serious injury or fatal electric shock.

- EWPs fitted with insulated personnel buckets must not be used for de-energised work on transmission assets.
- Palfinger NZ (the supplier of this personnel bucket) has approved the removal of the 1000V insulated panel from affected personnel buckets.
- A survey is underway across all Transpower Service Providers to better understand the extent of insulated personnel buckets in use within the industry.
