# SHE ALERT

## Low Voltage Cable Flashover

| Date of incident which is raised in days | 14-04-26 | Directorate | SEPD | | |

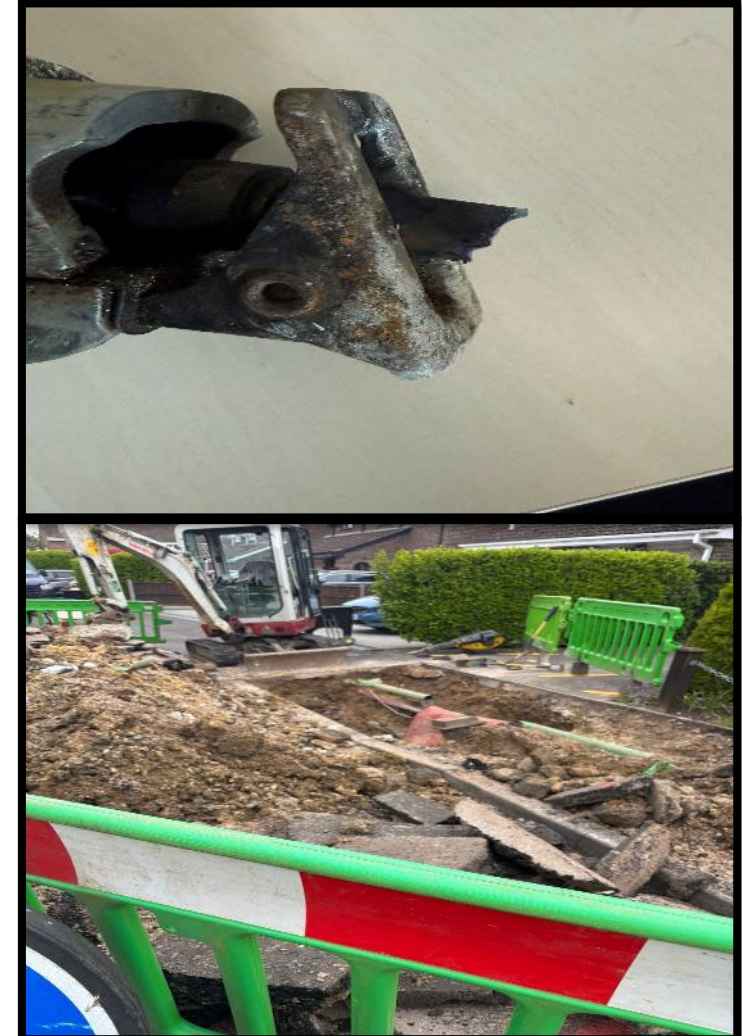
| <p>A Jointing team were working to repair a <b>Low Voltage</b> underground cable fault. One of the team members removed fuses at the local substation on what he thought was the correct feeder supplying the cable to be worked on.</p> <p>The jointer then incorrectly used a reciprocating saw to cut the cable, and this resulted in a flashover incident.</p> <p>The jointer sustained minor burns, attended hospital and was discharged later that day.</p> <p>As we investigate the incident further, while carrying out Jointing works apply the following :</p> <p><b>Relevant Documents - OSM's:</b></p> <p><a href="#">Operational Safety Manual - SSEN</a></p> <p><b>Section 10.1 of the Operational Safety Manual states:</b></p> <p><i>"Live working techniques <b>Shall</b> be used on <b>Low Voltage</b> underground cables even if the Conductors have been made <b>Dead and Isolated</b>. This approach is necessary because of the complexity and connectivity of the <b>Low Voltage</b> underground <b>System</b>, and to manage the risks associated with uncontrolled or inadvertent energisation of <b>Conductors</b>."</i></p> <p><b>Utilise your safety licence. If its not safe, we don't do it!</b></p> | | | | | |
