# SHE BRIEF

## Secondary Fault Causing Flashover During Excavation

# SHE ALERT

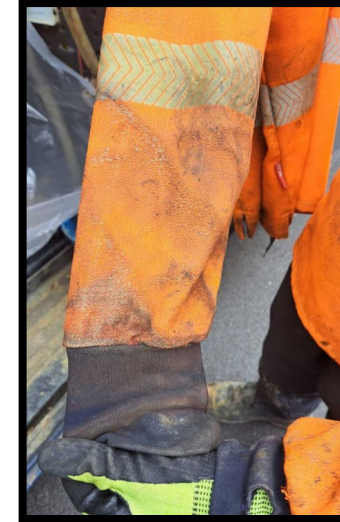
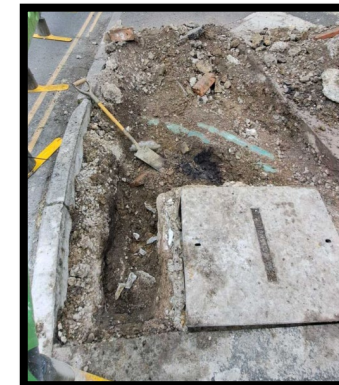
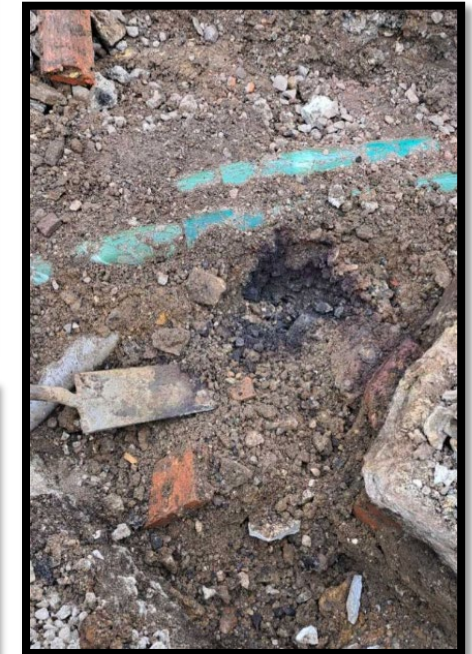
Operatives were tasked with a low voltage fault repair, during the excavation works a fault occurred. This was believed to be a secondary fault as the original fault had been located and marked up on the opposite side of the link box. Upon investigation it was found that there was no secondary fault on the network and the fault had been marked up in the incorrect position.

Had the team completed the correct network checks they would have found that the fault was on the side of the link box that they were working on. Fortunately, there were no injuries, and full PPE was being worn.

| <p>During Fault Investigation work for a faulty link-box, our operatives identified the fault to be on the far side of the link-box. They proceeded to excavate a joint hole at safe distance away from the suspected fault location, they then proceeded to hand dig to expose the cable, where an unexpected flashover occurred due to a secondary fault.</p> <p>At the time of the flashover, full arc rated PPE was being worn and performed as anticipated and approved insulated tools were being used. This ensured that our operative remained safe and unharmed.</p> <p><u><i>This incident is currently under investigation; however, it is important to remind all personnel to:</i></u></p> <ul style="list-style-type: none"> <li>• <b>Plan</b>, Wear the correct Personal Protective Equipment, refer to stage 1 POWRA and job pack.</li> <li>• <b>Scan</b>, Location of Cables, ensure all cables records are available and cables marked up onsite.</li> <li>• <b>Adapt</b>, Be prepared to apply your safety licence, and re-evaluate the risks at all times.</li> </ul> | | | | | |

Supervisors, line managers and operatives are reminded to refresh themselves on and reference the below documents when dealing with faults on the LV network.

- **Plan**, Ensure the correct job pack is issued and understood.
- **Scan**, Location of Cables, ensure all cables records are available and cables marked up onsite.
- **Adapt**, Be prepared to apply your safety licence, and re-evaluate the risks at all times.
