# SHE ALERT

## Fall From Ladder While Descending Grab Lorry

| Date of incident which is raised in days | 08/06/2026 | | Directorate | Distribution – Services SEPD | |

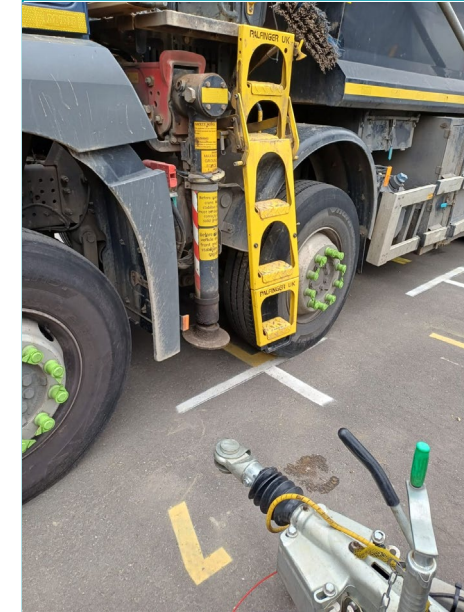
Our colleague attended Brockhampton Yard to collect shingle using a grab lorry. After climbing the ladder to operate the grab, they descended on completion of the task. As they stepped onto the final rung, they lost their footing and landed on both feet before stumbling backwards. They then struck the handbrake of a digger trailer and fell forward onto the trailer's ball joint, before finally coming to rest on the ground. Our colleague experienced discomfort and attended an emergency walk-in clinic, where X-rays confirmed fractured ribs. At the time of the incident, all appropriate PPE was worn. Safety boots were clean, correctly laced, and in good condition with adequate tread. The ladder was also clean and dry.

← This shows the position of the defected ladder that was used.

- Good Practice: When completing vehicle checks, its also good practice to check other parts that are not obvious on the vehicle check list like ladders, pins, clips, springs etc. making sure they are in place and in working order.
- **See It – Sort It – Report It:** Please remember that when completing vehicles checks to raise any defects found and follow up if necessary.
- **Plan – Scan – Adapt:** Remember to take a 20 second scan of your work area and look at any potential risks or hazards that could, in the event of an incident, cause you harm.

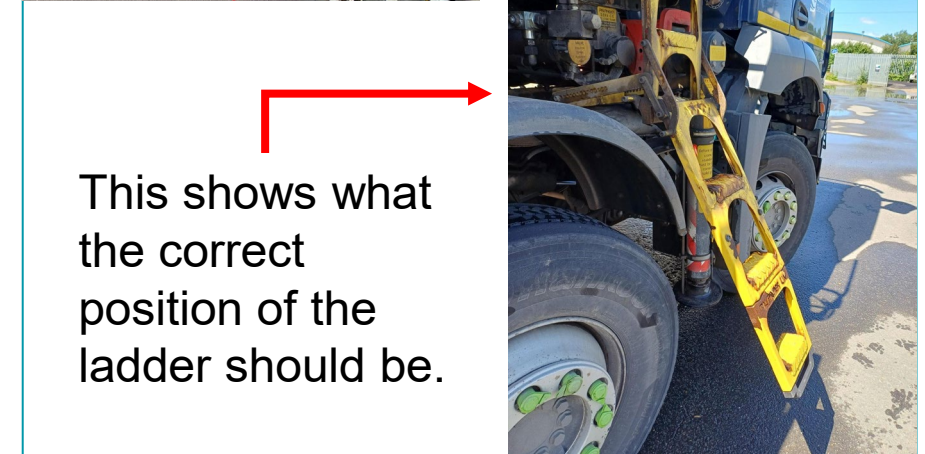
→ This shows what the correct position of the ladder should be.
