FIRST ALERT

Date: 20/04/2018

Maximo Reference: 114334

Induction Shock whilst in MEWP

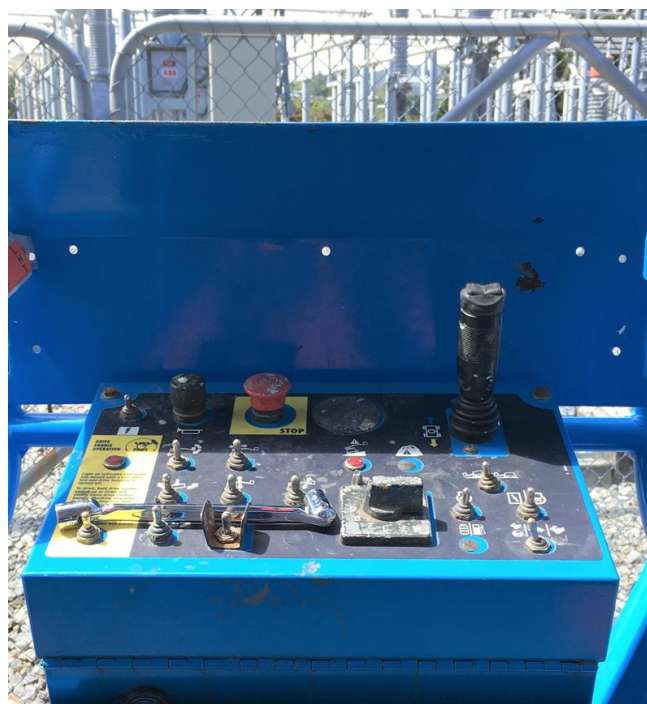
During a task involving the removal of aluminium panels from a capacitor bank noise enclosure within a 220kV filterbank at Haywards substation, a member of the Broadspectrum maintenance team received an induction shock from the earthed bucket control panel of the Mobile Elevated Work Platform (MEWP) that he was operating.

This occurred as the operator went to lower the MEWP. The panel being removed from the capacitor stack was the closest to the nearest live point, an adjacent filterbank outside MAD and 6 metres away.

It was identified that whilst waiting for the cover panels to be removed, the body of the team member (who was not in contact with any metallic parts of the MEWP) had become charged to AC voltage by capacitive coupling to the in-service Filterbank Busbar adjacent to the work location. With the team member at a different potential from the earthed and bonded MEWP, a shock occurred as he went to operate the controls in the bucket.

- Work was stopped immediately
- As a precaution measure the worker was taken to the hospital to be checked
- A Five WHY's and Short form ICAM report was completed and then entered into MAXIMO
- Gloves shall be worn when operating a MEWP
- Further recommendations as to how to mitigate the effects of this type of induction are being investigated
