# ENVIRONMENTAL START

## Accidental Discovery of Contaminated Soil Hangatiki and Kawerau Substations

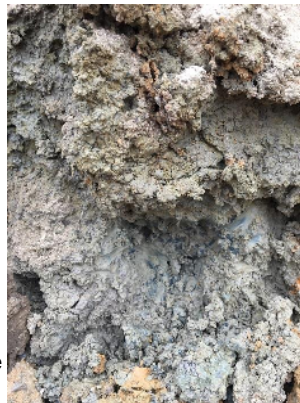
#### **Hangatiki Substation 12/09/2018**

During the excavation of shallow soil for the transformer pad as part of the switchyard extension works, discoloured and odorous soils were encountered. The odour was such that contractors experienced dizziness and slight nausea. The soil was found to be contaminated with hydrocarbons, likely associated with a slow leak from an oil tank that had been removed in the past.

- Works ceased immediately, and visibly impacted soils isolated
- Staff who felt unwell were taken to the local medical centre to be checked out, and were given the all clear.
- Suitably qualified professionals for contaminated land investigations were called to site to investigate the nature and extent of contamination.

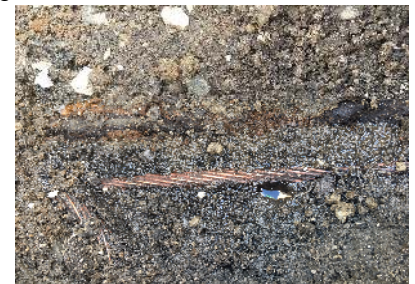
#### **Kawerau Substation 26/09/2018**

During demolition of a transformer foundation, as part of the site redevelopment works, an oily substance was discovered. After initial testing, the soil was found to have high readings of hydrocarbons with some traces of polychlorinated biphenyl (PCBs). The results from further testing are imminent and will determine the source and severity of this contamination.

- Work close to the contamination was immediately ceased.
- Additional soil testing was carried out to determine the nature and extent of contamination.
- Further earthworks in other areas on site are to be overseen by a suitably qualified professional.
