# Life On-Line:

Lichen Growth and its Impact on Insulators

James Bai

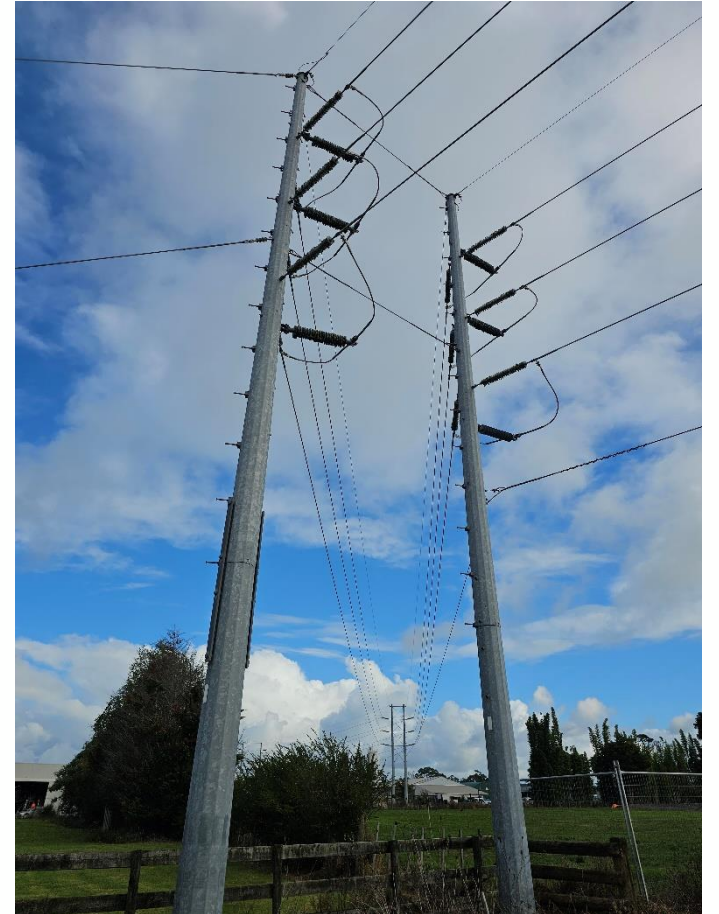
- Lichen observed on insulators on WPA-WRR 33kV circuits
- Line is built to 110kV standards but only operated at 33kV
- Site is located in Waipapa, Northland
- Waipapa is a mostly industrial area near Kerikeri
- Most environmental drivers for lichen growth met
- Doubts over air quality, but generally good

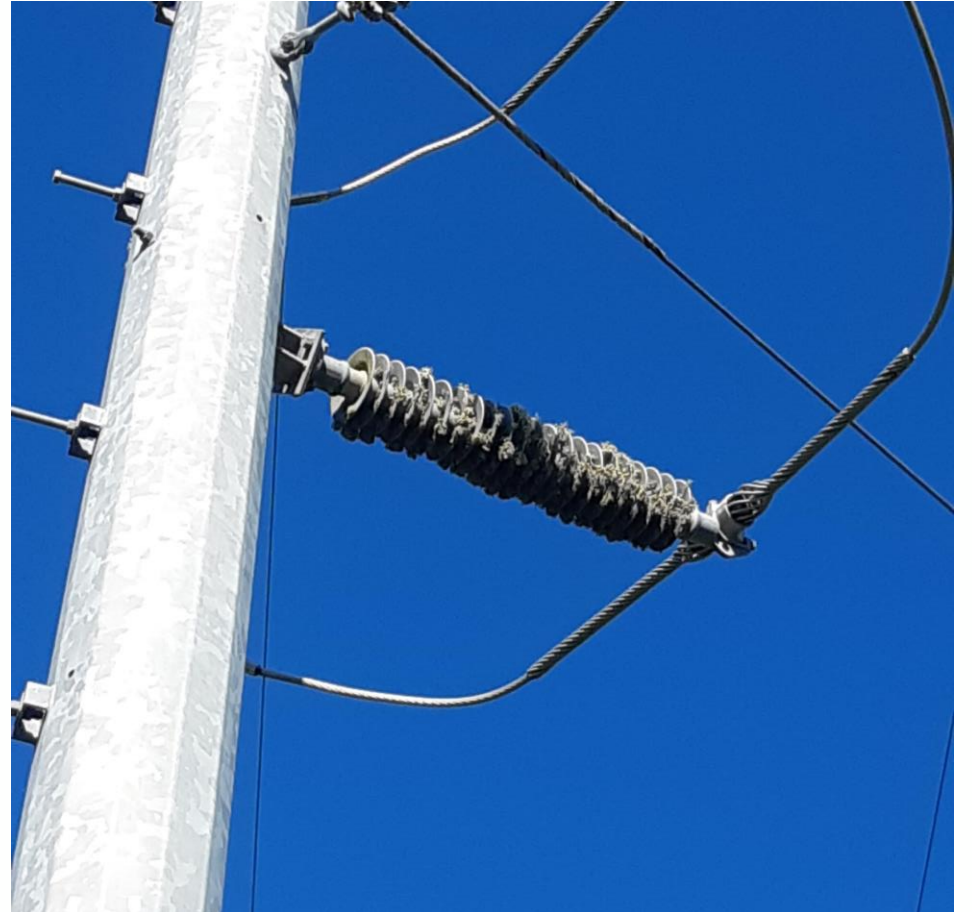
- 110kV composite line post (HTV Silicone rubber housing)
- Operated at 33kV
- Installed in 2005, ~21 years in service
- Approaching end of life
- Significant lichen growth observed

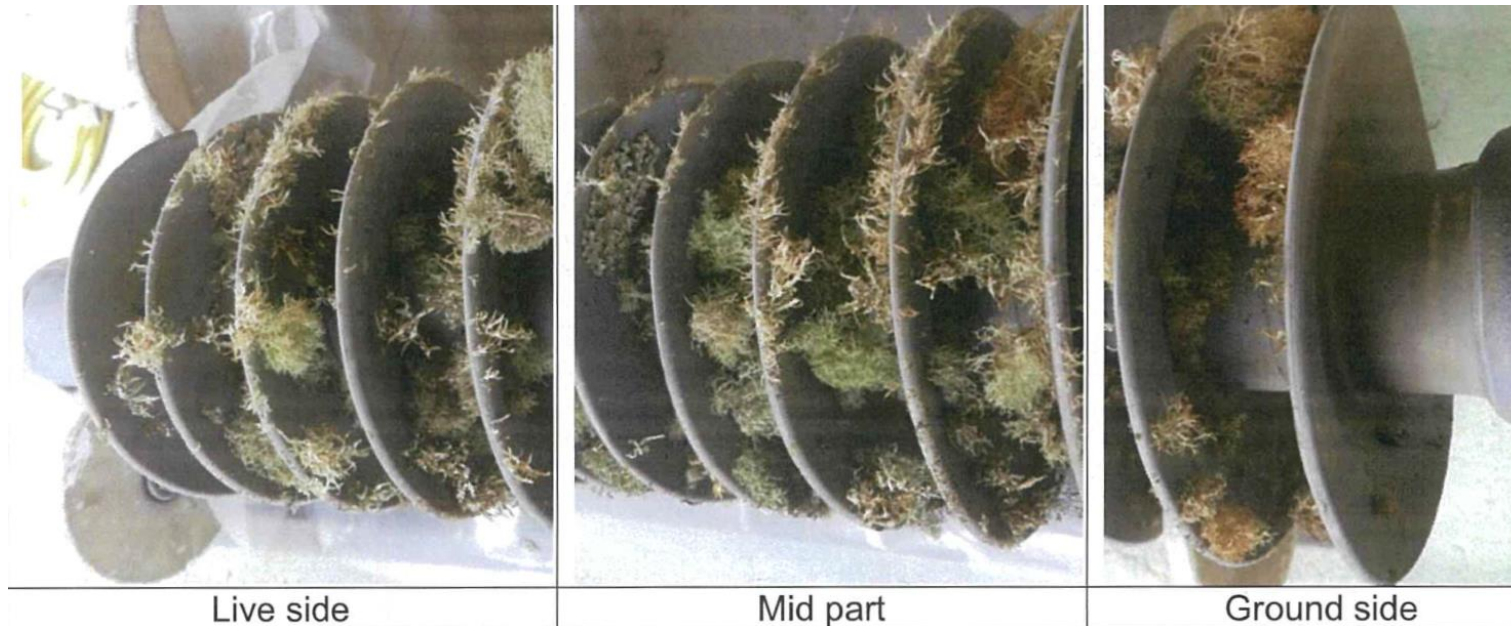
- Continuous biological growth observed along entire Silicone body
- No trace of degradation, erosion, electrical activity, or debonding of the Silicone

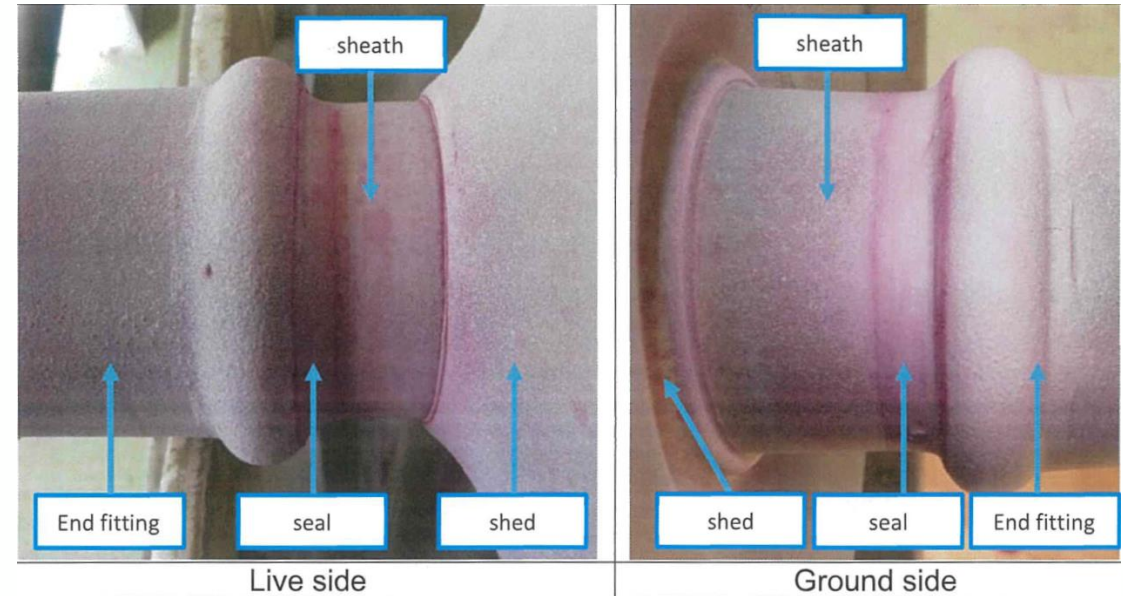
- Dye penetration used on both ends of insulator
- Very light de-bonding of the edges of the seals and sheds
- Deteriorations are superficial
- Consistent with normal ageing

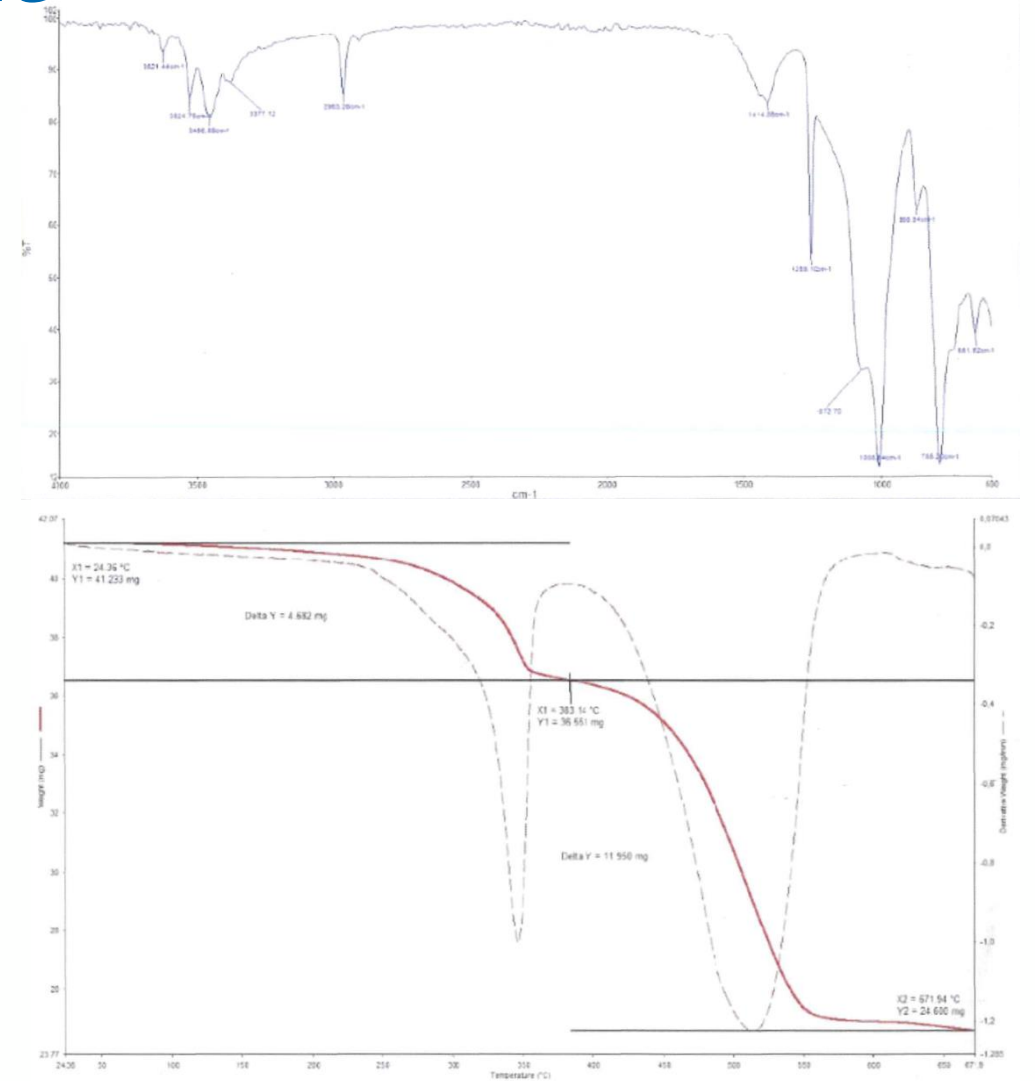
- Fourier Transform Infrared spectrum and Automated Thermogravimetry analysis confirms material is HTV silicone rubber with ~68% ATH filler
- Shore A hardness is  $\sim 50 \pm 5$  (within expected range)
- Density is  $\sim 1.625 \text{ g/cm}^3$  (consistent with new material)

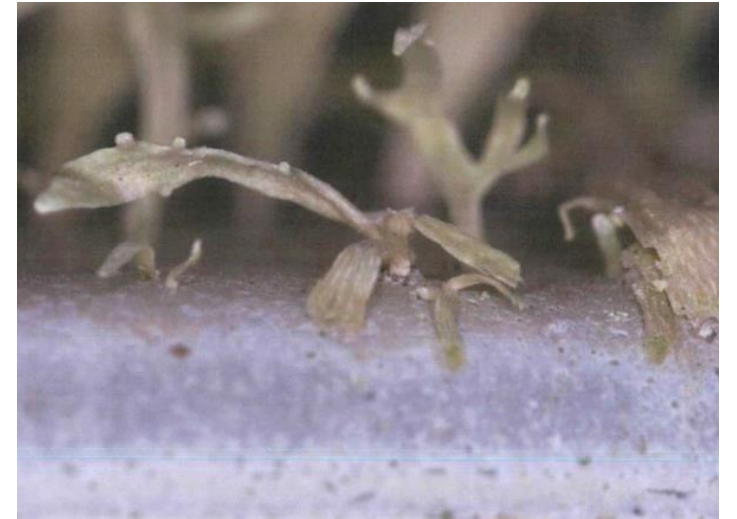
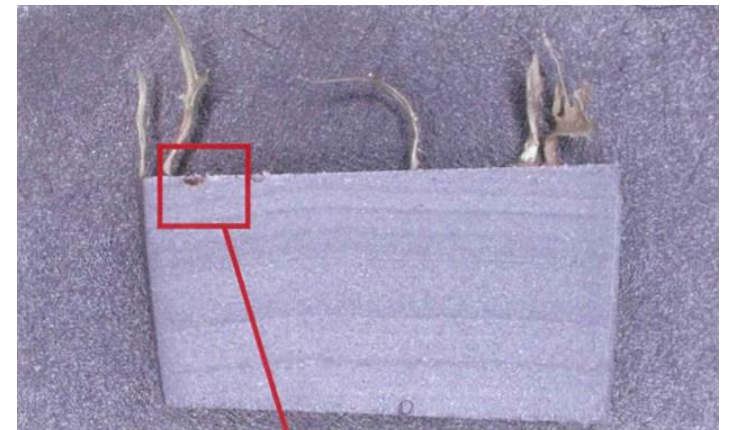
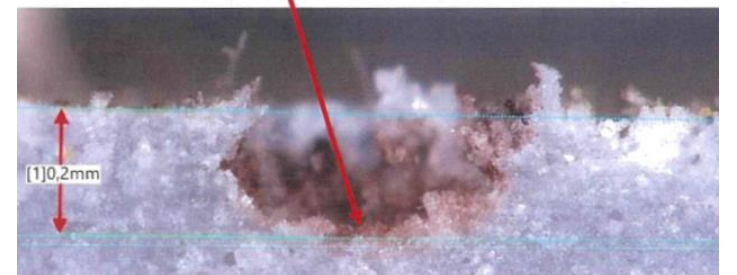
- Lichen embedded via roots in Silicone surface
- Root penetration depth limited to  $\sim 0.2$  mm
- No propagation into bulk silicone
- Hydrophobicity loss is minimal and localised to root pores

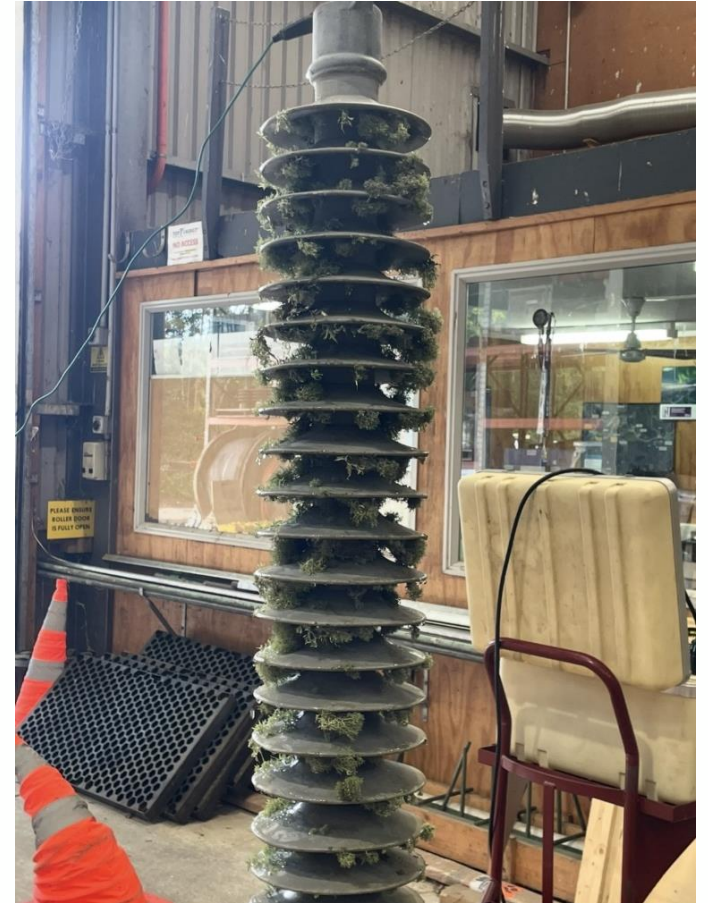
- Flashover voltage test performed under dry and wet conditions
- Voltage increased from 20kV to 140kV (equipment limit)
- No electrical flashover occurred in any test

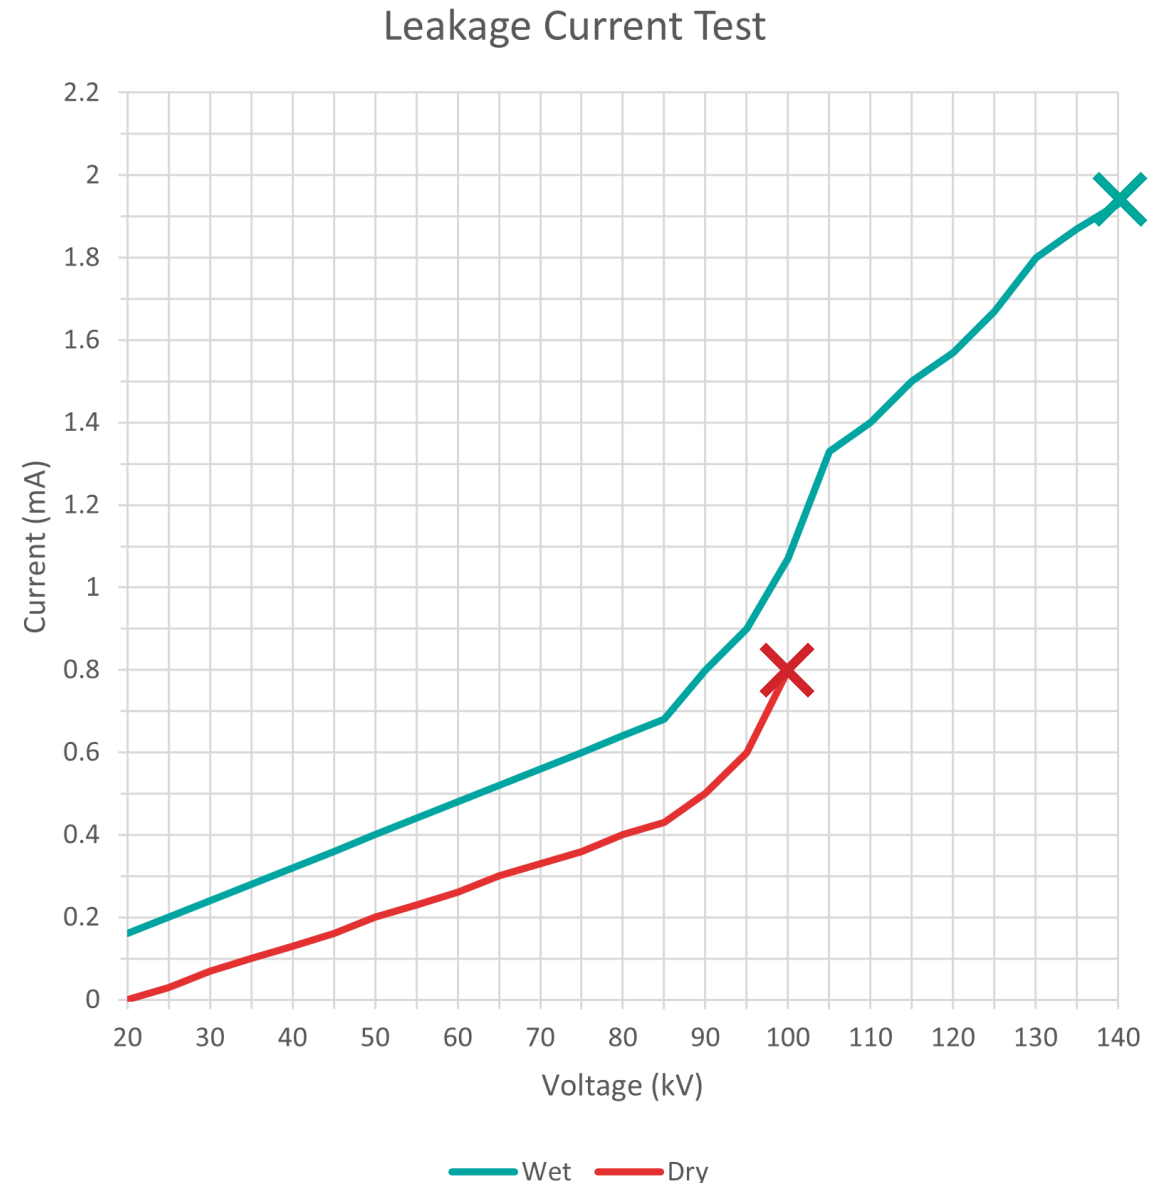
- Leakage current measured under dry and wet conditions
- Voltage increased from 20kV to 140kV (equipment limit)
- Dry test aborted at 100kV due to noticeable lichen destruction
- Dry: ~0.8mA at 100kV
- Wet: ~1.9mA at 140kV
- Results consistent with clean insulators

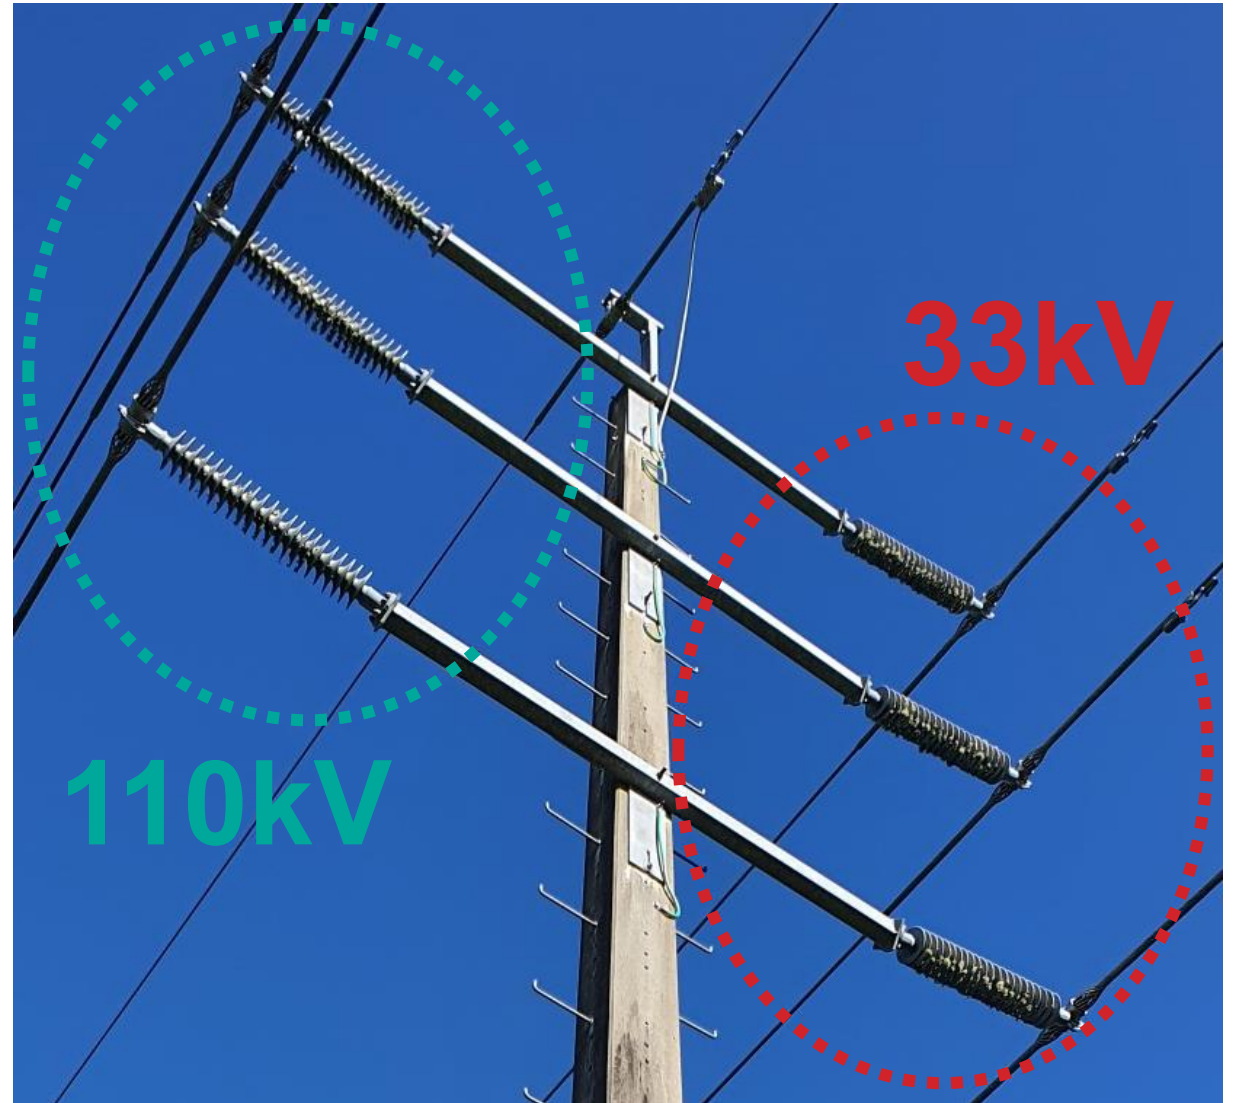
- Significantly more lichen growth observed on 33kV side
- It is hypothesised that lichen growth on Silicone insulators is limited when operated at higher voltages
- It may also be true that lichen growth is destroyed above an specific voltage threshold
- More testing and monitoring over time will be required to confirm this
