Ref. No: HSE002/17 Date of Issue: 13/03/2017

WHAT HAPPENED:

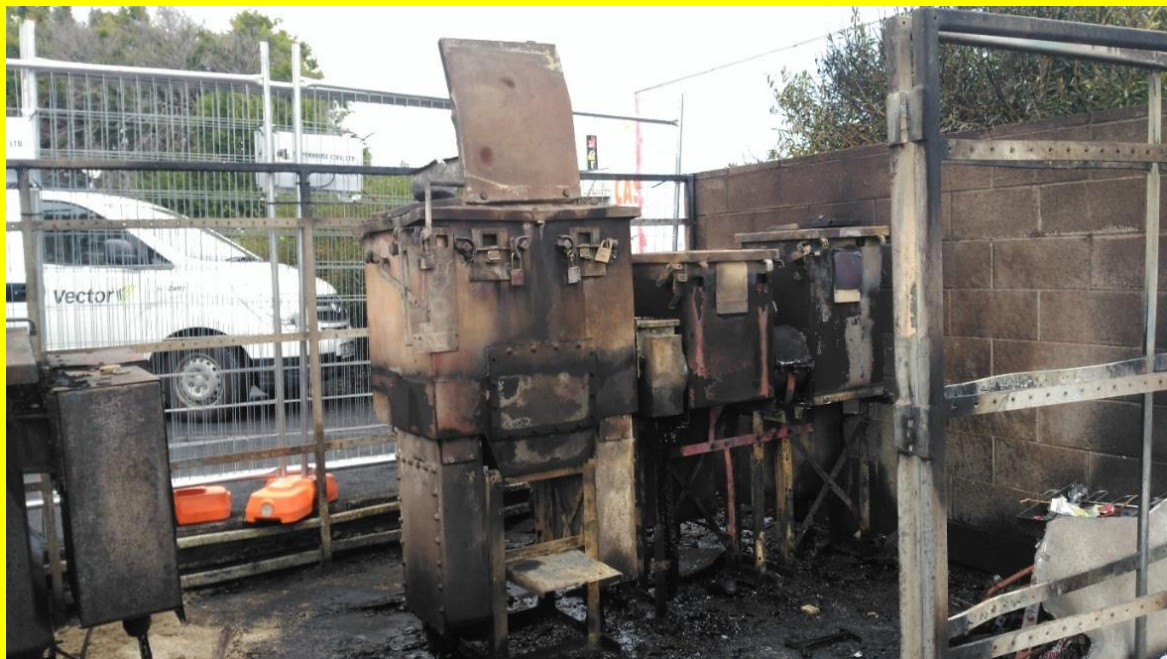
9. Shortly after completing this operation the unit exploded and the immediate area suffered fire damage. Oil and internal parts from inside the switch were spread over 25 metres from the switch. The debris was ejected from the fuse access cover towards the rear of the switch as per its vent path.

1. The switch had passed an oil sample test in 2015 and prior to the incident showed no signs of distress. As part of their normal processes the fault persons had confirmed the safe appearance of the switch prior to commencing work, including a visual check on the interior of the tank while changing the fuses, and found no cause for concern.
2. All physical operations affecting the switch were performed correctly.
3. The fault persons were following the oil filled switchgear safe working practices, including keeping an exclusion zone from the switch during the stand-down periods prior, during and post re-livening of the switch from a remote location.
4. Workers did not undertake any live operation of any mechanisms on the Long and Crawford switch following the fuses operating as a result of the initial cable fault.

- Any activity which requires internal access into the fuse-switch or switch unit including access to the HV fuse compartment, must only be carried out once the unit has been completely isolated from the electricity supply
- Where a fuse has or may have operated, including operation of the switching and earthing mechanism, any activity must only be carried out once the unit has been completely isolated from the electricity supply.
- The minimum time between completion of any internal activity and the re-livening of the equipment shall be 15 minutes.
- Re-livening of the fuse-switch or switch unit shall only be performed using a remotely located (adjacent) switch
