Safety Alert – SA390

Near Miss – Underground Cable Strike

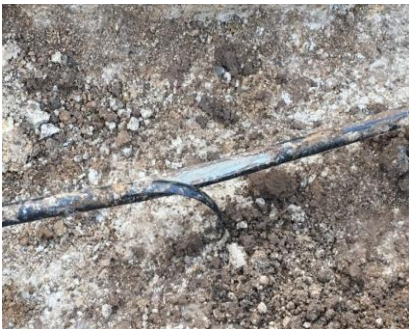
Incident		Description	
Date of Even	27/04/2017	14:00	Hamilton Substation
Investigation Status:		Ongoing	
Event Description:	<p>During excavation to install ODJB182. Northpower subcontractor hit an underground cable. The cable insulation was damaged but no damage was done to its armour. It is unknown at this stage if the cable is in service, but everything indicates that it is a redundant cable. No warning tape, mag slab or pvc conduit was found before hitting the cable, although it was known that a non-identified service was underground (earth, cable, oil pipe). Permit to dig was in place, correctly applied and measures implemented as per Maintenance Contractor recommendations.</p> <p>The digger operator involved is experienced, the digging was done as per other excavations on the yard, the equipment and the operator competencies were in order.</p>

<p>Cable insulation damaged</p>
Conclusion:	<p>The digger bucket inadvertently damaged the cable when removing the crushed rocks on the excavation area although the cable was not located within that ground layer (negative identification). This could have been prevented by making the cable visible (positive identification) before removing any ground layer.</p> <p>Failure to identify the service before removing the first layer of soil.</p>

Actions Required / Messages:	<ul style="list-style-type: none"> Consider all options for implementing safe digging practice in accordance with SMP 06.19.003 Minimize excavation by design as in this case the ODJBs could have been placed on the existing ducts from the start. 		
TP.SS.06.19.SA2	Permit to Dig Requirements for Transpower Ground Disturbance Work		
Incident Contact Person:	Janine Wagstaff
