## Asbestos Contaminated Soil and Gravel at Stratford

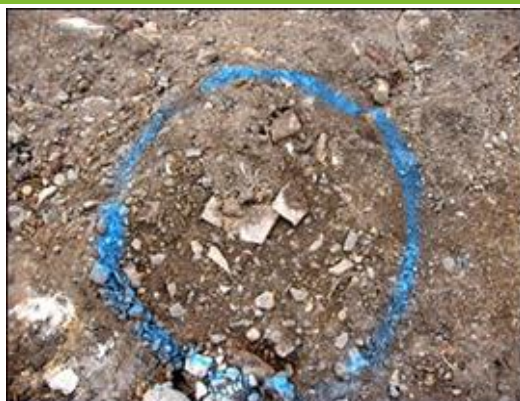
Asbestos has been found within the soil matrix and gravel at Stratford substation during an asbestos assessment.

The Asbestos was found inside and outside the yard.

Poor building and demolition practices in the past.

External contamination from industry and transport close to the site.

- Further assessments were arranged immediately.
- RPE requirements have been put in place for the station:
  - A 1-stage decontamination zone at the main gate, with a lockable bin that contains a bin liner.
  - Standard access to site requires the need to wear overboots which will be provided at the gate.
  - Access requiring work that will potentially involve normal PPE coming in contact with the ground will require both overboots and a flame retardent paper overall.
  - Access where soils and gravels will be agitated and disturbed by any means will require the work to be supervised by a Licensed Asbestos removalist.
- Before entry, contact
  - **Electrix** Deon Kotze 021386992
  - **Downer** James Gordon 0278863911

- Pre-construction asbestos assessments should be carried out before any ground penetration.
- Refer to [TP.AMG 47.01](#) 'Asbestos Management Plan' and [TP.SS 06.55](#) 'Asbestos on Transpower Sites', these can be found under Controlled Documents of the [Transpower Website](#).
- More information can be found on the [Asbestos Management page](#) of the Transpower Website.
