Asbestos fuse cylinder found during assessments

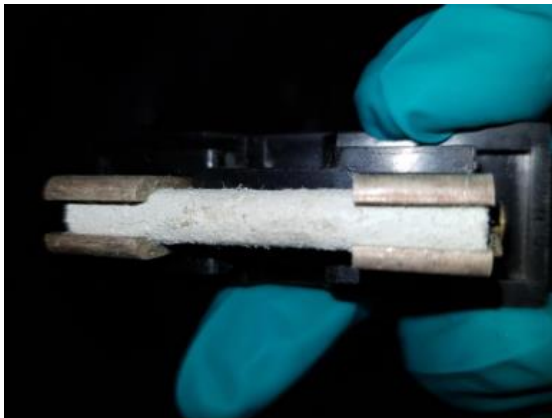
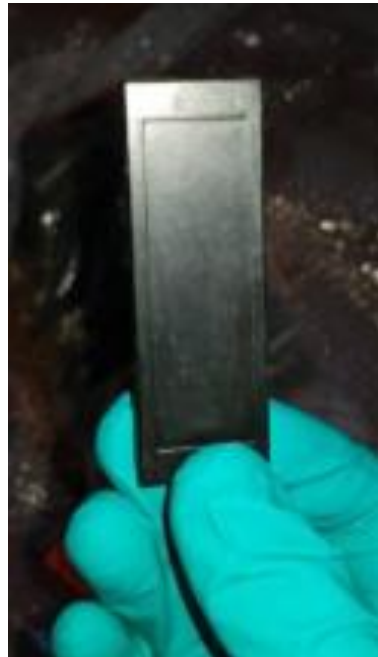
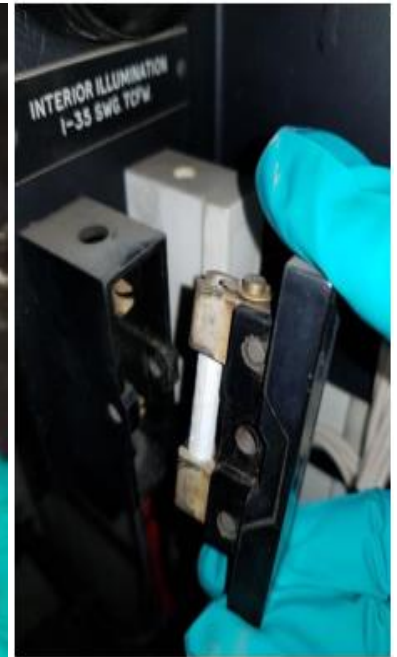
During an asbestos assessment one of the assessors inspected an out-of-service fuse carrier and fuse. The fuse cylinder was made of Chrysotile Asbestos.

Historic use of asbestos is common in our network. As long as we do not disturb asbestos containing material (ACM) there is no potential for exposure.

- A sample was taken and a label applied.
- The enclosure was closed off and the personnel were informed.
- The Service Provider was informed.

- Asbestos has been used extensively in the past and we should always be vigilant when carrying out work on our assets.
- Use TP.SS.06.55 for guidance on any asbestos related issues you may encounter on site.
