# QUALITY ALERT!

## Core Rot in Hardwood Transmission Poles

Quality Alert REF No : 2017-007

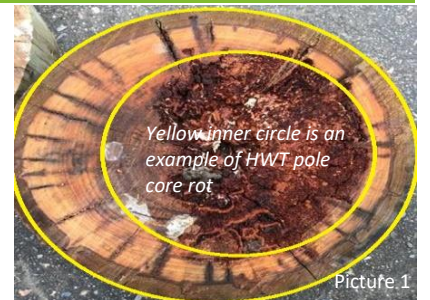
Picture 1

All Hardwood treated (HWT) poles are susceptible to **core rot**, an example of core rot is shown in *Picture 1*. These poles tend to have straight longitudinal grain and a smooth surface. **Radial cracks** can occur and may extend to the centre of the pole allowing **moisture ingress** to the **untreated centre**. Core rot can therefore occur at any point along the pole length, but typically **starts below ground** and works upwards throughout a 3-4m length of the pole.

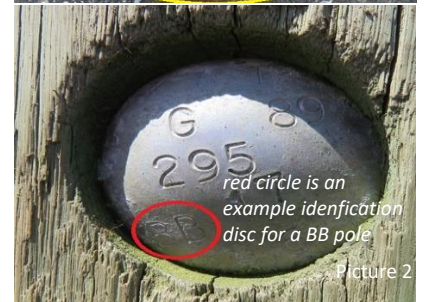
Picture 2

The type of hardwood species may be identified by the species code on the pole identification disc, see *Picture 2*. Typical HWT poles on the network are “BB” Blackbutt; “RI” Red Ironbark; “NI” Narrow-leaved Red Ironbark and “SG” Spotted Gum. Generally BB poles have been found to have the greatest magnitude of core rot on our HWT poles to date.

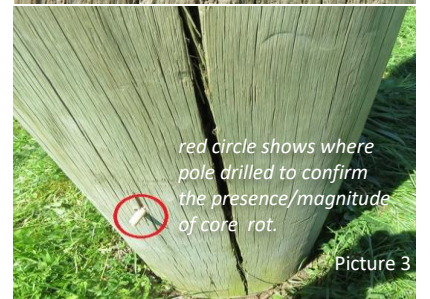
Picture 3

**Extra care** is therefore required during **Condition Assessment (CA)**, particularly where radial cracks are identified, as whilst from an **outward appearance** poles can appear to be in **good** condition, **core rot** may have **developed**. For this reason **hammer testing** of all HWT poles should be conducted along the pole length with **special attention** paid to locations **where cracking** is observed. The sound reflections of the hammer blows can be a **good indicator** of the presence of core rot thereby prompting additional investigation. **Good CA practices** on Pi-Pole 70 EDG-KAW A line were successfully applied. The pole diameters were right 300mm and left 308mm at the test bore points. After initial CA measures **identified concerns** these poles were then drilled (*Picture 3*) to confirm presence and magnitude of **core rot**, approximately **100mm** found in the right pole and **120mm** in left.

- Discuss this Alert with appropriate staff
- Ensure CA staff are fully aware of this issue and ensure it forms part of their CA process
- These poles, when changed out, will be cut in cross section to display the level of core rot
- These cross sections will be sent to Omaka and be used for training purposes
