FIRST ALERT

Date: 6 May 2016

Equipotential Bonding

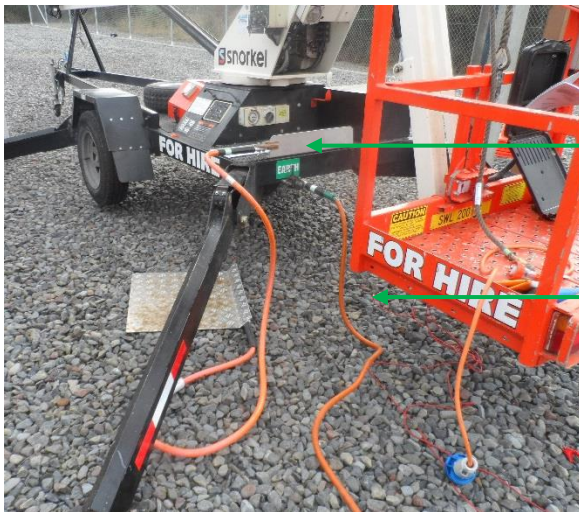
During routine maintenance at Tangiwai Substation a site audit identified unsafe bonding practices associated with bonding of mobile plant to the earth grid. The operator plate and EWP/station earth had been connected in series. Correct bonding is required to create a safe equipotential zone for the work party. Correct Earthing arrangement is shown below.

Operator plate independently connected to MEWP
(TP SS 07.24 diagram F2)

Earth bond/lead from MEWP to station earth

- The work was temporarily suspended until the earthing was rearranged as per the service specifications TP SS.07.24 and the SMEI Part 3, Section 6 (Isolation and Earthing for work on HV Electrical Equipment).
- Bonding corrected to comply with Transpower Service Specifications and to make the work site safe.
- Discussions held at the monthly team meetings highlighting the importance of correct bonding practices.
- Mike Taylor (Consultant) has been engaged to run earthing refresher sessions with teams to reiterate Transpowers requirements and highlight good safety practices.
