Islington SVC 9 Capacitor Fire – 15 Feb 2016

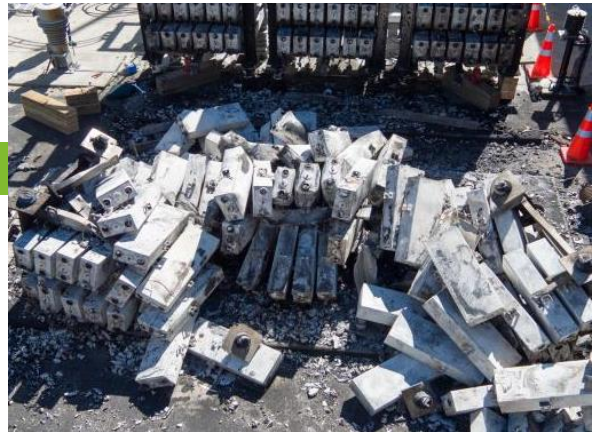
On the 15th of February 2016 there was a fault and significant fire in the Thyristor Switched Capacitor compound of Transpower's Islington Static VAR Compensator (SVC) 9.

Although the direct cause is yet to be established, a number of potential causes and opportunities for improvement have been identified. When reviewing other recent capacitor failures at other sites, one of the modes of failure of capacitors relates to the overheating and failure of an electrical connection at the bushing terminal, leading to melting of bushing solder, release of oil, and potentially fire. A number of other causes are also being considered.

- Ensure correct connection hardware is used and is installed in the correct sequence (e.g. Bellevue washer). Use electrical contact grease between conductors, clamps, and terminal bolts;

- Check and ensure that clamps and materials are in good condition (no cracks etc). Check connections are torqued to manufacturer specifications and are not over or under tightened. Ensure the bushing cap does not twist during tightening. Mark the torques when completed;

- Extra care should be exercised when handling capacitor cans to not damage the bushings or cause oil leaks;
- It is important to routinely carry out thermovision surveys of capacitor terminal electrical connections and especially after return to service following disconnection/reconnection of terminals;

- Immediately report signs of terminal overheating or oil leaks to the TP Service Delivery Manager (SDM);
- Ensure that grout and fireseals are correctly installed. For PVC pipe, grout should penetrate to below the adjacent concrete level to prevent spread of burning oil. Notify TP SDM or PM if not installed correctly;

- Remove flammable birdproofing materials or use alternative non-flammable materials. Flammable materials may add to the development/spread of a capacitor fire. Review use of materials with TP SDM or PM.
