# FIRST ALERT

Date 07/06/2016

Maximo Reference: 91977

## Trailer Incident – Woodville Substation – Foot injury

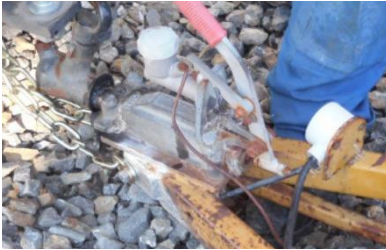
Re-enactment of how the injured employee's foot was trapped

As the tow-ball detached from the Ute the load on it shifted sideways and caused the trailer to drop. As it fell, the drawbar came down on to the second employee's foot, trapping it, striking just behind the steel-cap (partially on the back of the steel-cap). Employees on site assisted the injured employee, using various tools to lever and remove the trailer from the employee's foot.

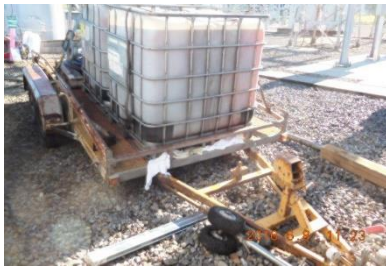
The trailer and load

They were parked on the substation metal, and the trailer was sitting at a slightly higher level than the Ute. The trailer was loaded with oil (weighing approximately 2 tonnes).

The employees were unable to deploy the jockey wheel as the trailer was too low to the ground. An employee decided to use the Ute jack to assist with the detachment and placed it underneath the drawbar of the trailer. A second employee was holding the locking latch up while this was done.

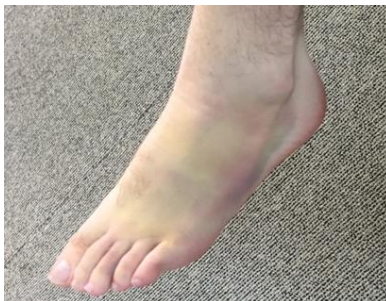
Bruising to the employees foot

- Employees on site assisted the injured employee with lifting the trailer off his foot.
- The injured employee attended at a medical centre with bruising and swelling to his foot. X-rays were undertaken (these ruled out any bone damage) and he was assigned to light duties for one week.
- An investigation is underway.
